**Diploma Thesis**

**Feasibility study of river restoration measures and  
the patency of migration barriers on the Knovízský  
stream**

**Author:** Bc. Kateřina Dvořáková

**Prague 2014**

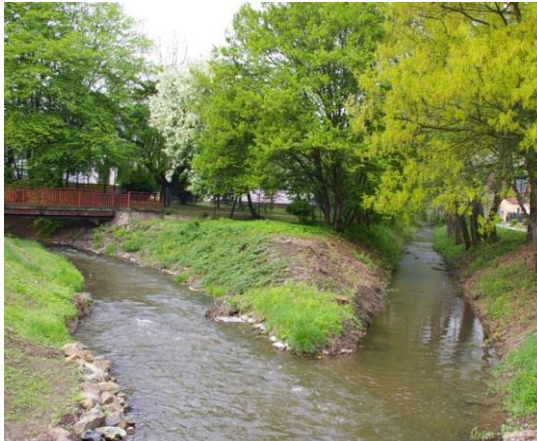
**Figure 13** Confluence with Zákolanský stream. Left side: Zákolanský stream, Right side: directly flowing stream bed of Knovízský stream

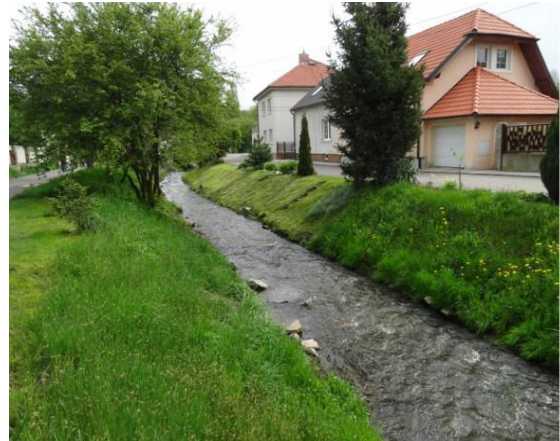
**Figure 14** Stones in the stream bed increase the diversity of flow

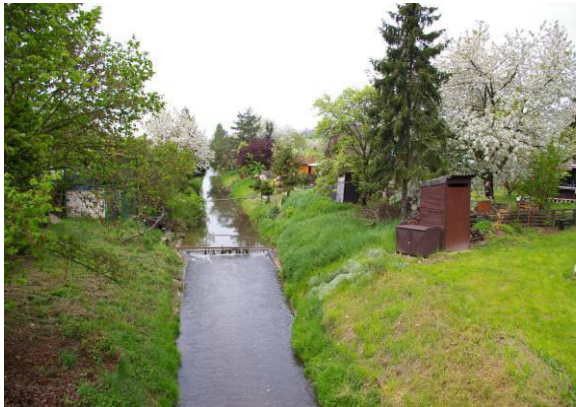
**Figure 18: Artificial man-made dam in summer house area**

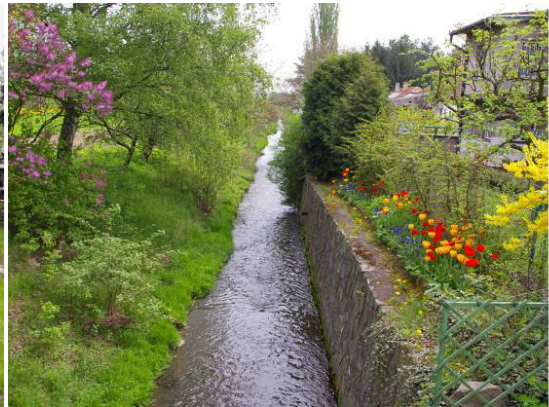
**Figure 19: The concrete wall in summer house area**

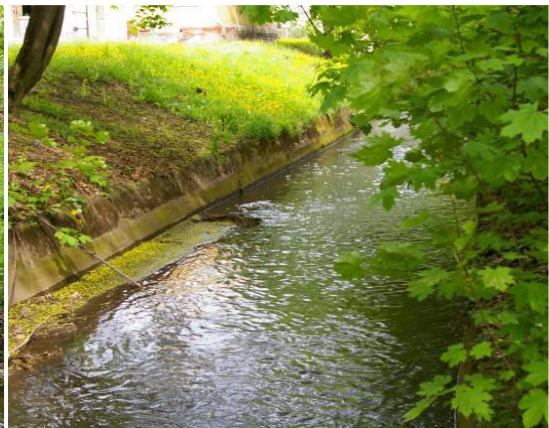
At the beginning of the village Olovnice, the stream bed changes its shape into a concrete channel. The channel has a rectangular cross-section made by concrete blocks. In this way, the stream is reinforced until the end of the section, i.e. the road bridge on river kilometer 4,678.

**Figure 21: A concrete channel in Olovnice village**

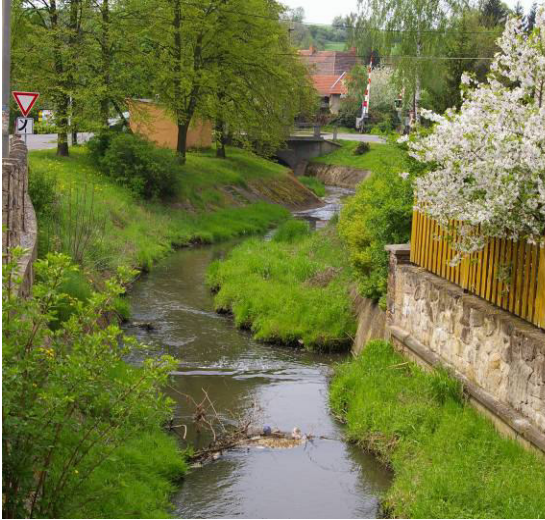
**Figure 23: Concrete channel in Olovnice village**

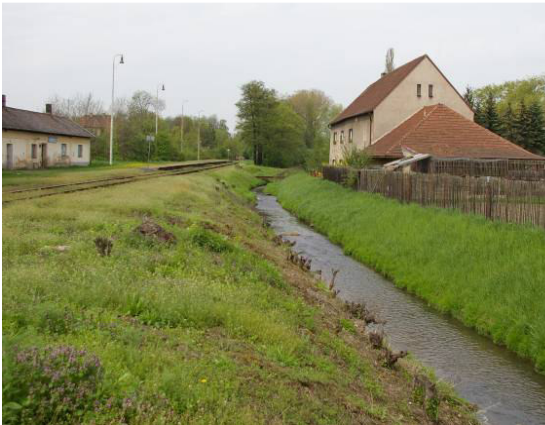
**Figure 25: Knovízský stream is limited by the railway**

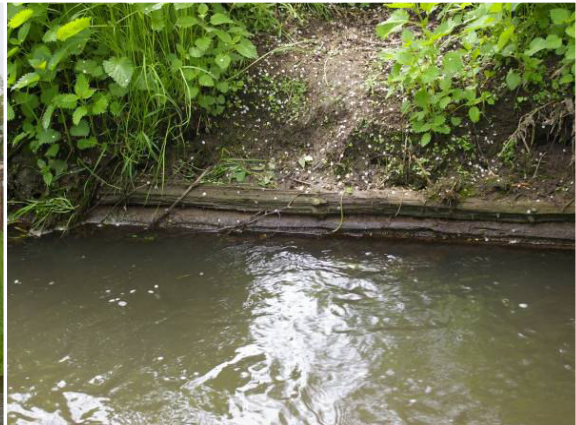
The stream continues to non urban area where it is reinforced with lattice fence. Then, the stream flows out into the urban area of the village Kamenný most. In this village, there is a pond on the left stream bank side. The Knovízský stream is in the village reinforced by stone riprap and masonry lining. The character of the stream bed is very similar to the previous sections. From the left side, the stream is limited by the railway.

**Figure 26: Lattice fence enforces the banks in between village Neuměřice and Kamenný most**

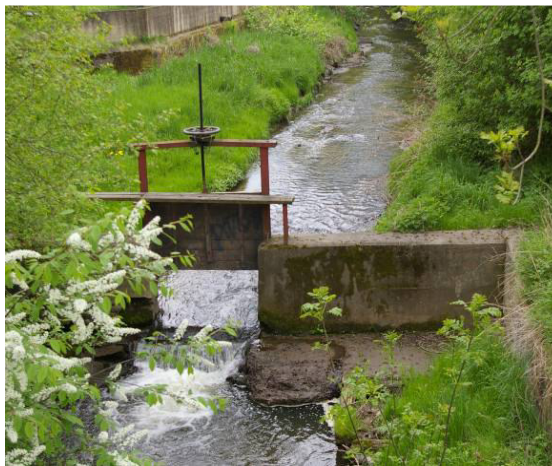
**Figure 32: Weir with water gate after the canalization**

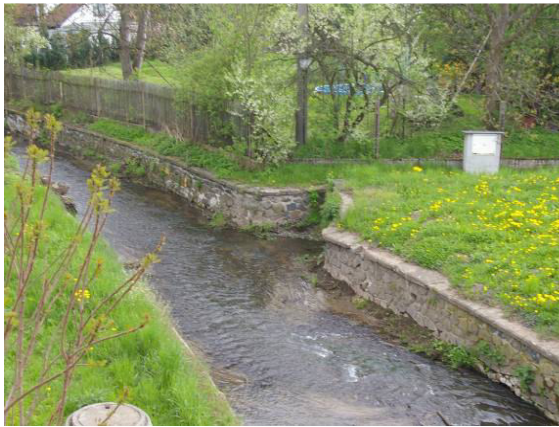
**Figure 37: Stream enhancement in the the village Knovíz**

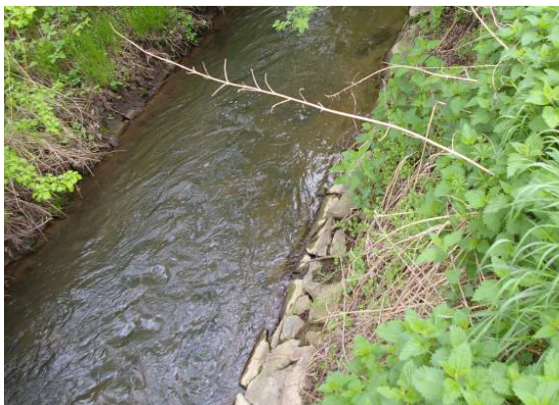
**Figure 39: Bank enhancement in the non urban area after the village Jemníky**

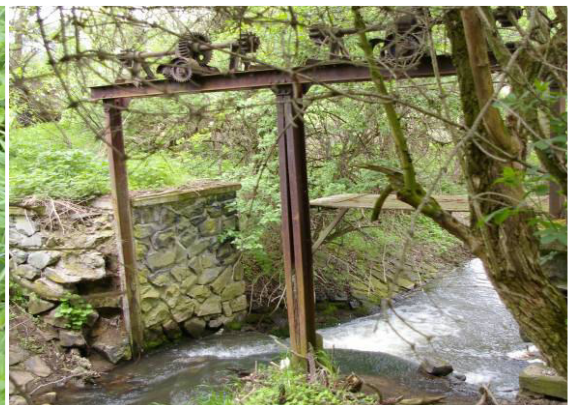
**Figure 40: Old weir with water gate – the iron structure**
