Vysoké učení technické v Brně
Fakulta strojního inženýrství
Ústav konstruování

VOLUMETRIC WEAR ANALYSIS OF HIP JOINT IMPLANTS BY OPTICAL METHODS

Disertační práce
Dissertation Thesis

Brno 2018

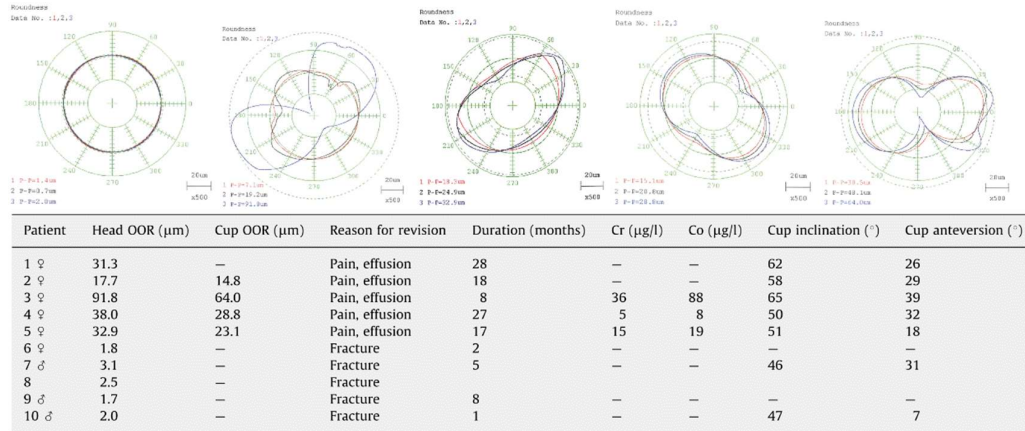
Joyce et al. [31] used another method for wear analysis of retrieved metal-on-metal liners to compare the out of roundness results with clinical complications of patients. The wear was analysed in three planes and results diverged from circularity (Fig 2.10 Maximum out of roundness values of the explanted components and the associated clinical data [32]). The analysis showed that failures associated with effusion and pain in patients were associated with out of roundness values far higher than the manufacturing tolerances. These results were supported by the high ion levels seen in the blood of patients. In addition, all these failures were associated with cups positioned at high angles of inclination and anteversion.

Fig 2.10 Maximum out of roundness values of the explanted components and the associated clinical data [32].

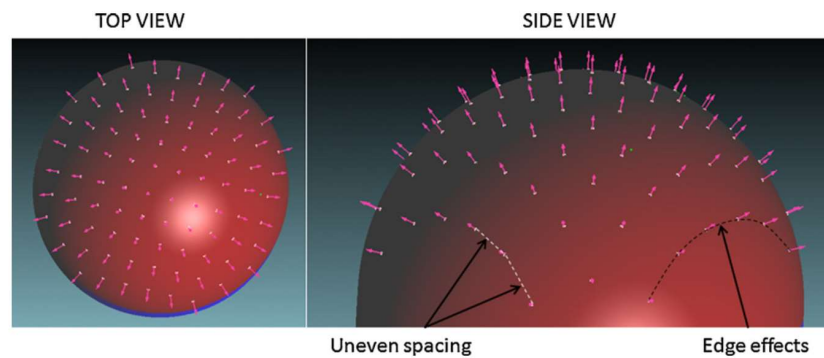
Measurement errors of the coordinate measuring method were described by Bills et al. [38]. The study analysed the uncertainties associated with measurements of spherical geometries and applied them to both the measurement of wear in retrieved bearings and metal hip resurfacing components. The influence of measurement uncertainty was showed to be of a significant order for the coordinate measurement method. The study showed that the grid definition and performance of the meshing algorithms can significantly influence the results (Fig 2.12). It is therefore also suggested that the grid spacing should be adapted to component size. The analysis was carried out on six explanted metal-on-metal hip replacements.

Fig 2.12 Effect of mesh spacing

The measurement error demonstrated for the volumetric wear was between 1,145 and 1,859 mm^3 .

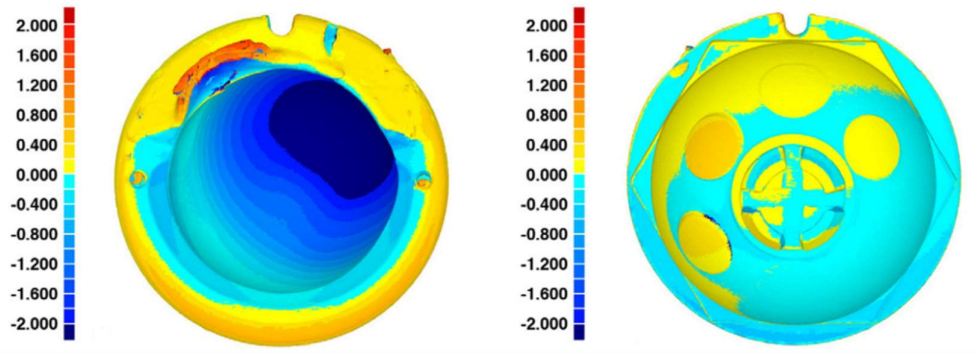
deviation of the articular surface was -2.48 ± 0.02 mm, with maximum backside deviation of 0.46 ± 0.02 mm.

Fig 2.16 Three-dimensional volume images of the retrieved acetabular liner scanned using micro-CT [44]

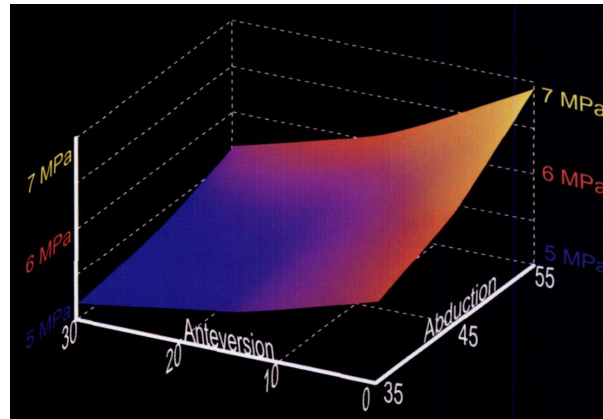
Fig 2.30 Increase in the abduction angle increase peak contact stress according FME analysis [66].

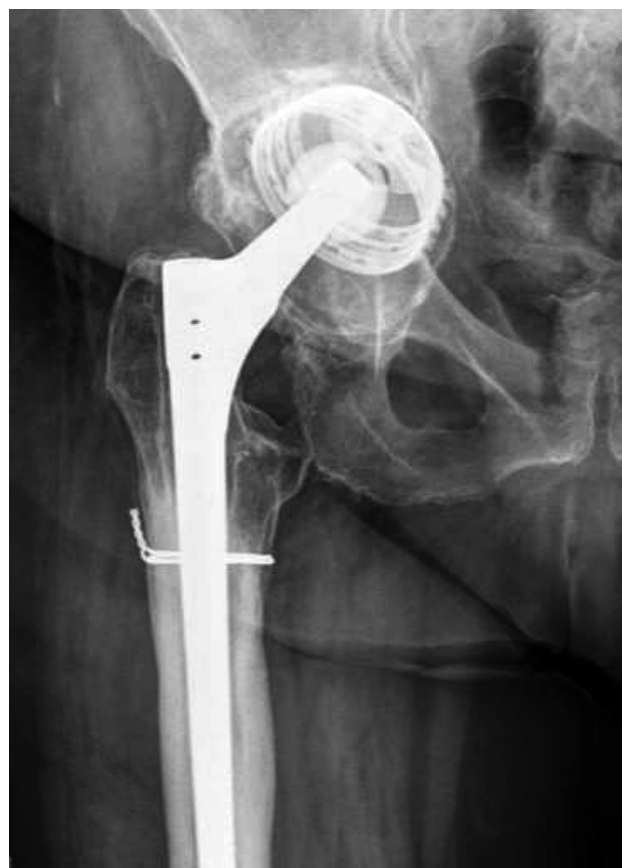
Obr. 1. Aseptické uvolnění jamky Bicon.
