**Identifying activities leading to the worsening of the
ecological status of the Botič Creek and proposal of
restoration measures**

MASTER'S THESIS

Prague 2024

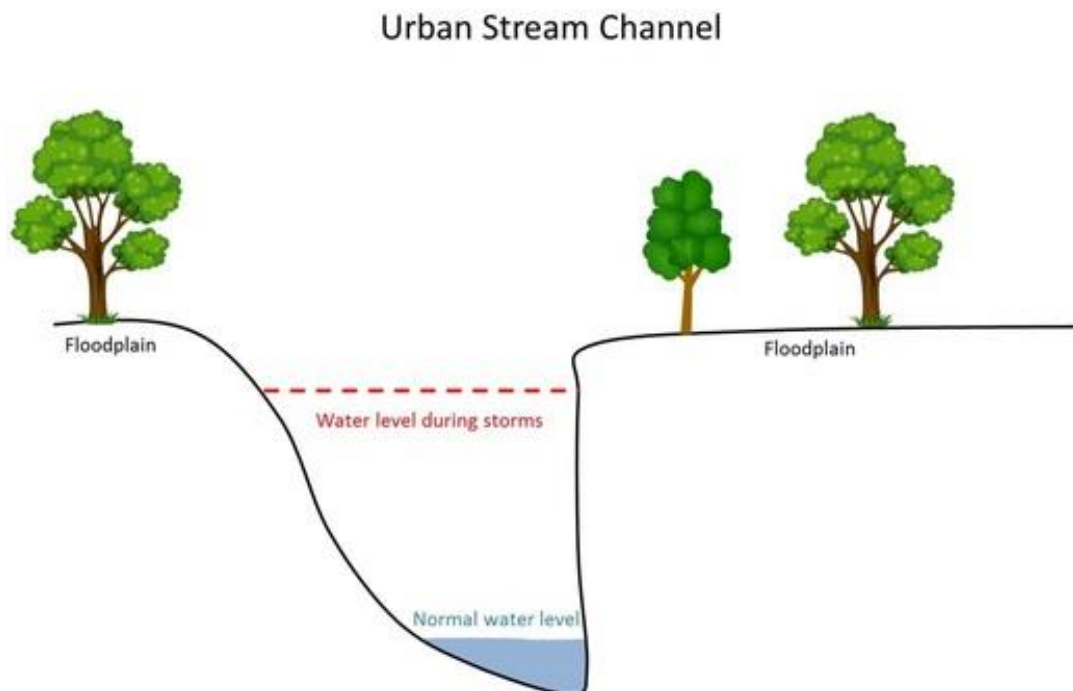
Figure 2. Typical Stream profile for an urban stream. Source: (Shannon White, 2016)

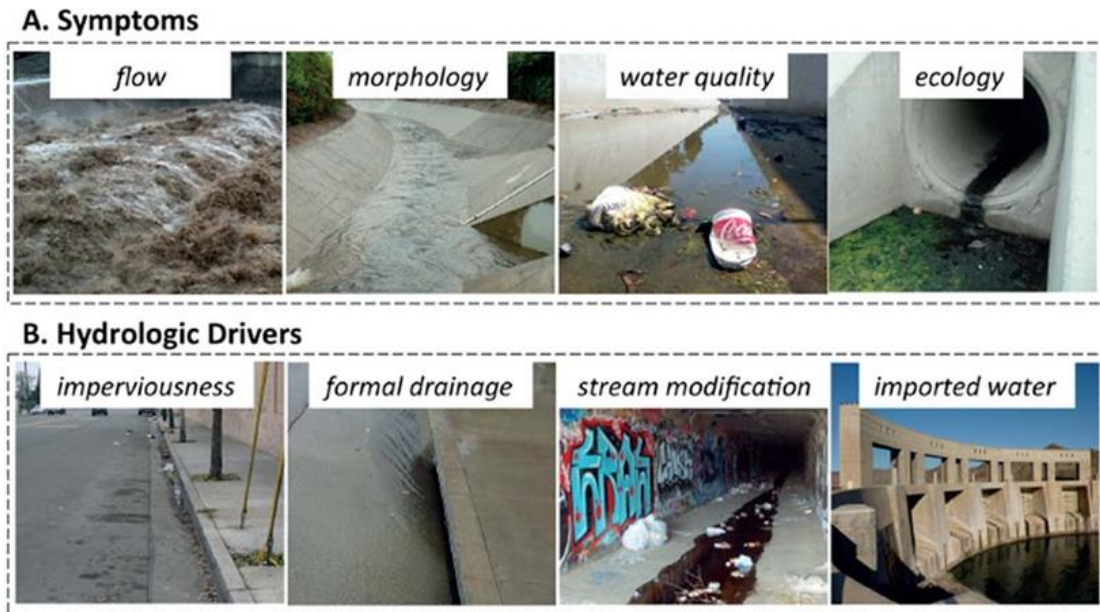
Figure 5. Symptoms and hydrologic drivers of urban stream syndrome. Source: (Feldman, 2017)

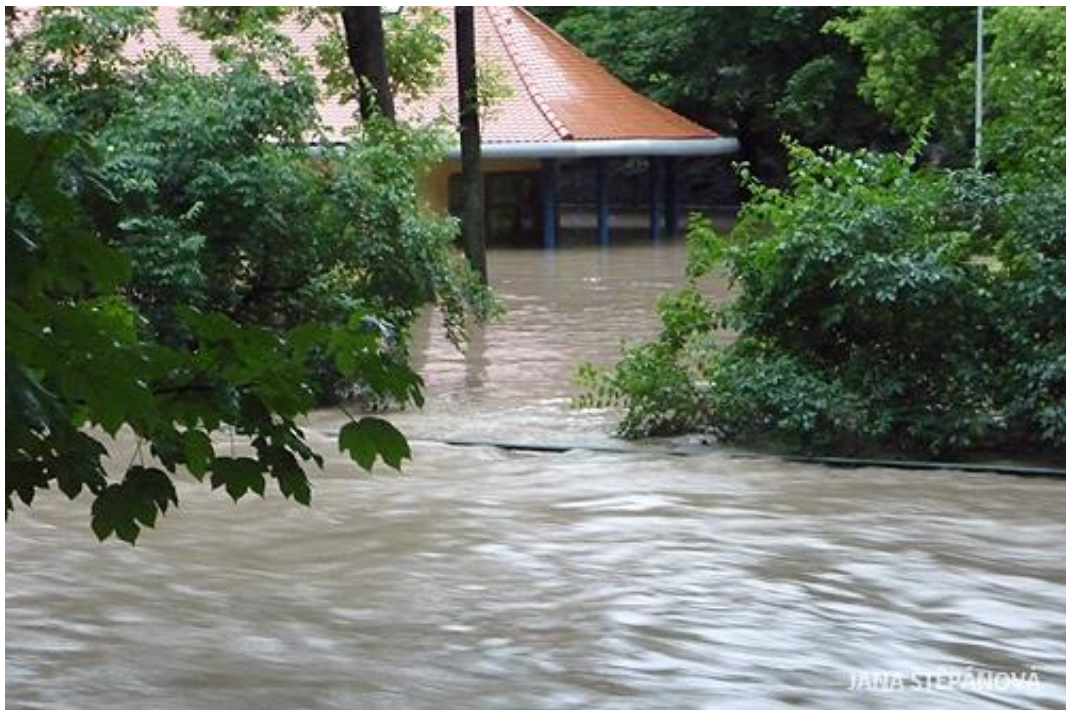
Figure 15. Folimanka Park: Cafe flooded. Source: (Štěpánová, 2013)

The regions that were most impacted by the floods included Benice and Průhonice, where water levels exceeded flood thresholds. Hostivař Dam was carefully managed to prevent overflow and a potential breach that could have flooded areas such as Michle, Vršovice, and Nuslí. Flooding occurred in specific areas, such as U brehu street, old Hostivař development, gardens in Záběhlice, and the Záběhlic castle area experienced backflow from a tributary stream. Buildings in old Záběhlice, sports facilities, and areas below the Hamerský pond were flooded. Water spilled into Hamerské pond from Botič. The marshalling yard, KARE buildings, and car repair shops were also impacted. While localized flooding occurred in specific areas of Michle, Vršovice, and Nusle, major bridges remained unaffected (**Figure 15, 16 & 17**; Daňhelka et al., 2013).

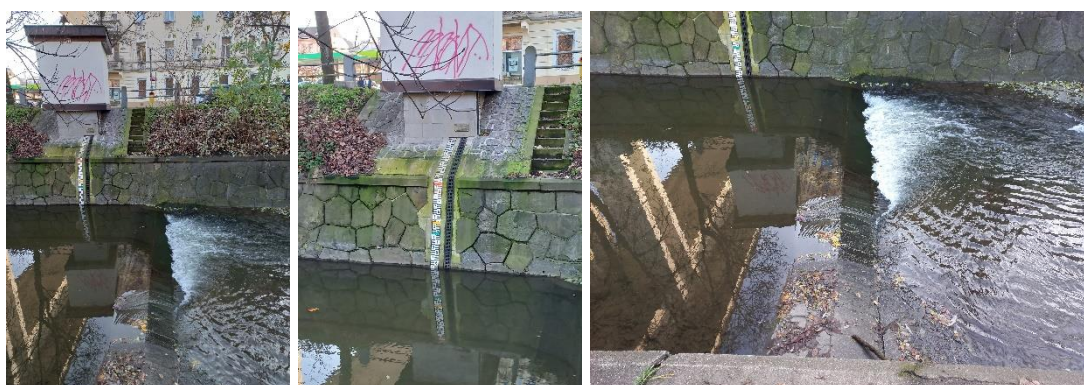
Figure 18. Images showing the limnigraphic station at Prague - Nusle. Source: Author

Monitoring practices: In 2016, new pressure sensors and ultrasonic-level gauge technology were installed at seven limnigraphic stations in the Botič basin (**Figure 18**). In addition, each measuring profile was upgraded with a new water level batten, and certain areas of the watercourse bed underwent improvements to enhance measurement accuracy (**Table 6**). The Kocanda, Průhonice, Kuří, and Dobřejovice stations outside Prague monitor water conditions and flows in the upper Botič basin. This data is vital for predicting downstream flows and essential for water management, flood control, and environmental protection (Sweco hydroprojekt, 2019).

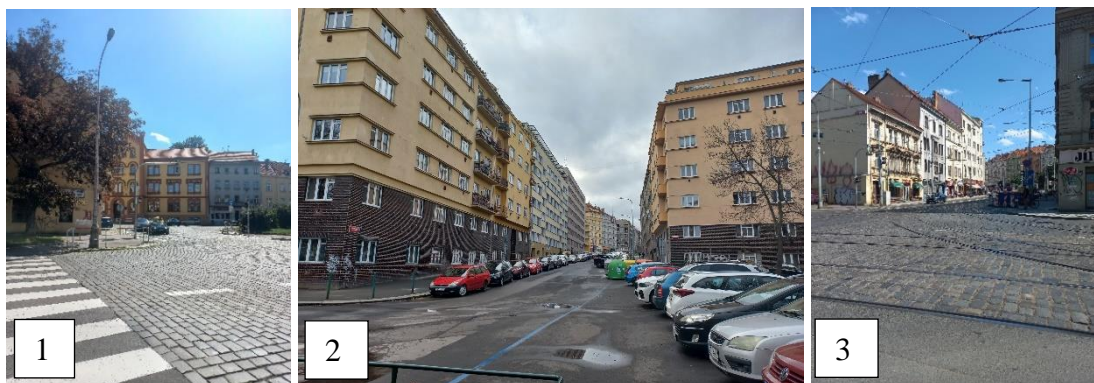
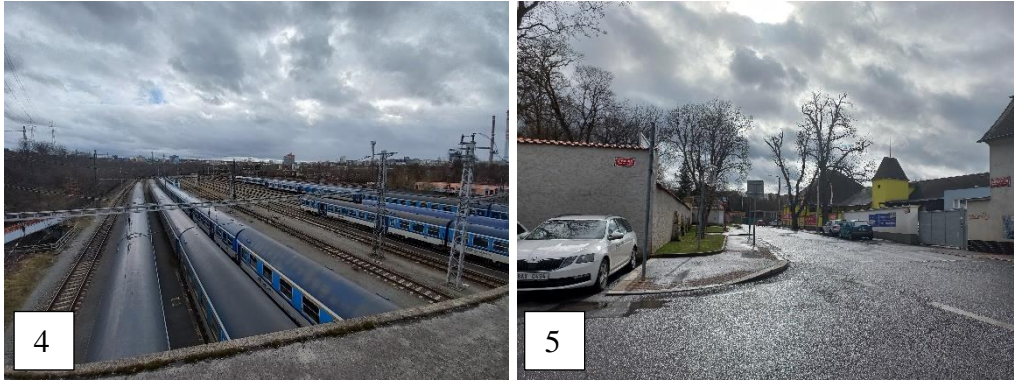
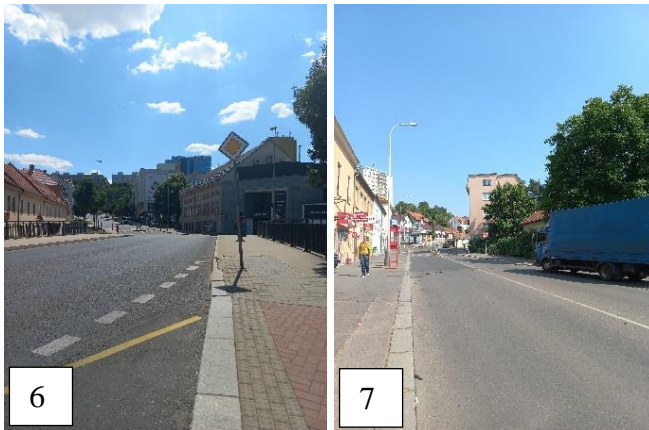
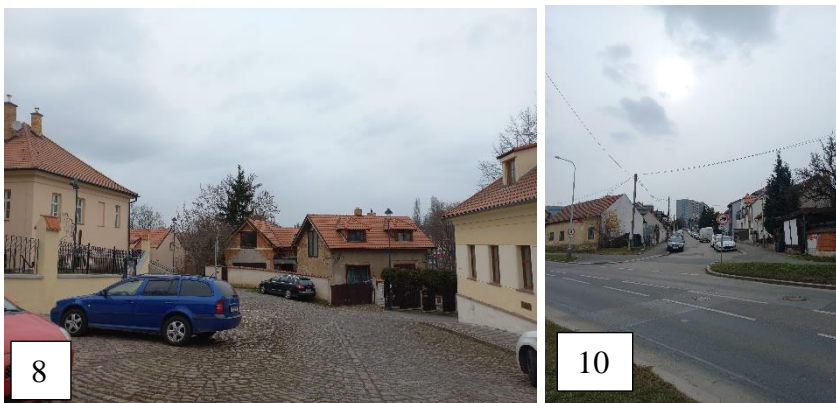
a. Impervious surfaces observed in the watershed.

The impervious surfaces included roadways, tram lines, train station, walkways, buildings, and parking areas. The numbers listed in the photographs correspond to the locations marked on the map (Figure 23) and labelled in (Table 10).

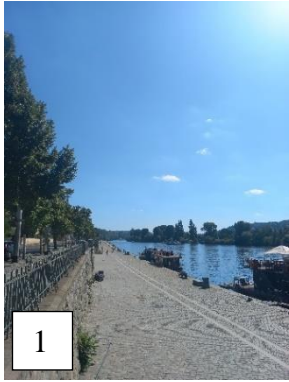
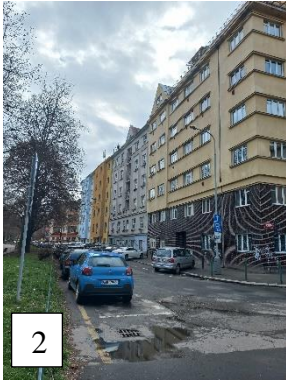
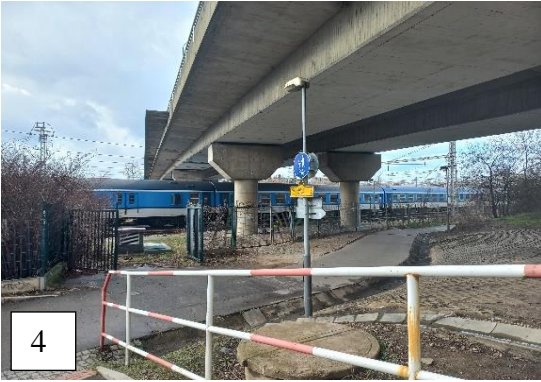
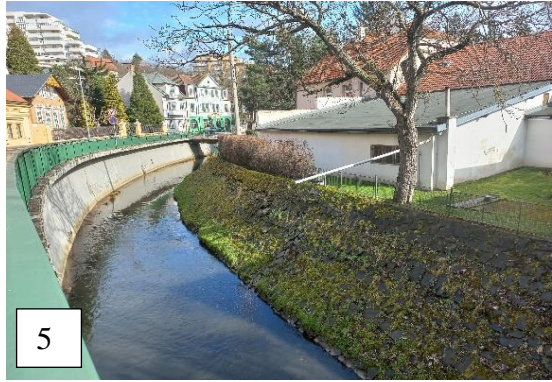
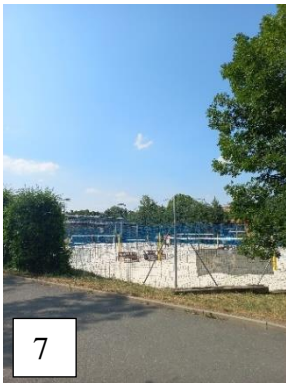
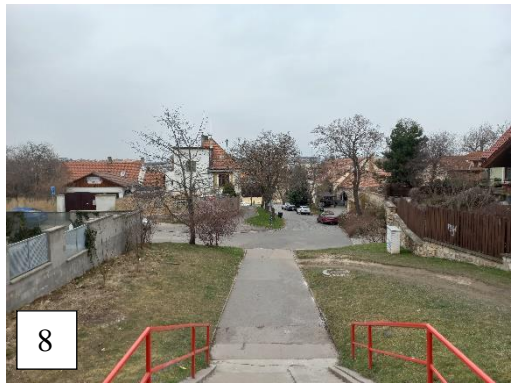
The land use categories in the site locations included transport lines: railway lines and stations, tramways and roadways, built-up areas: residential, commercial, parking, sports complexes, recreation, and community spaces; natural areas: public parks, boulevards with walkways, natural parks, retention ponds, reservoirs. The numbers listed in the photographs correspond to the locations marked on the map (Figure 23) and labelled in (Table 10).

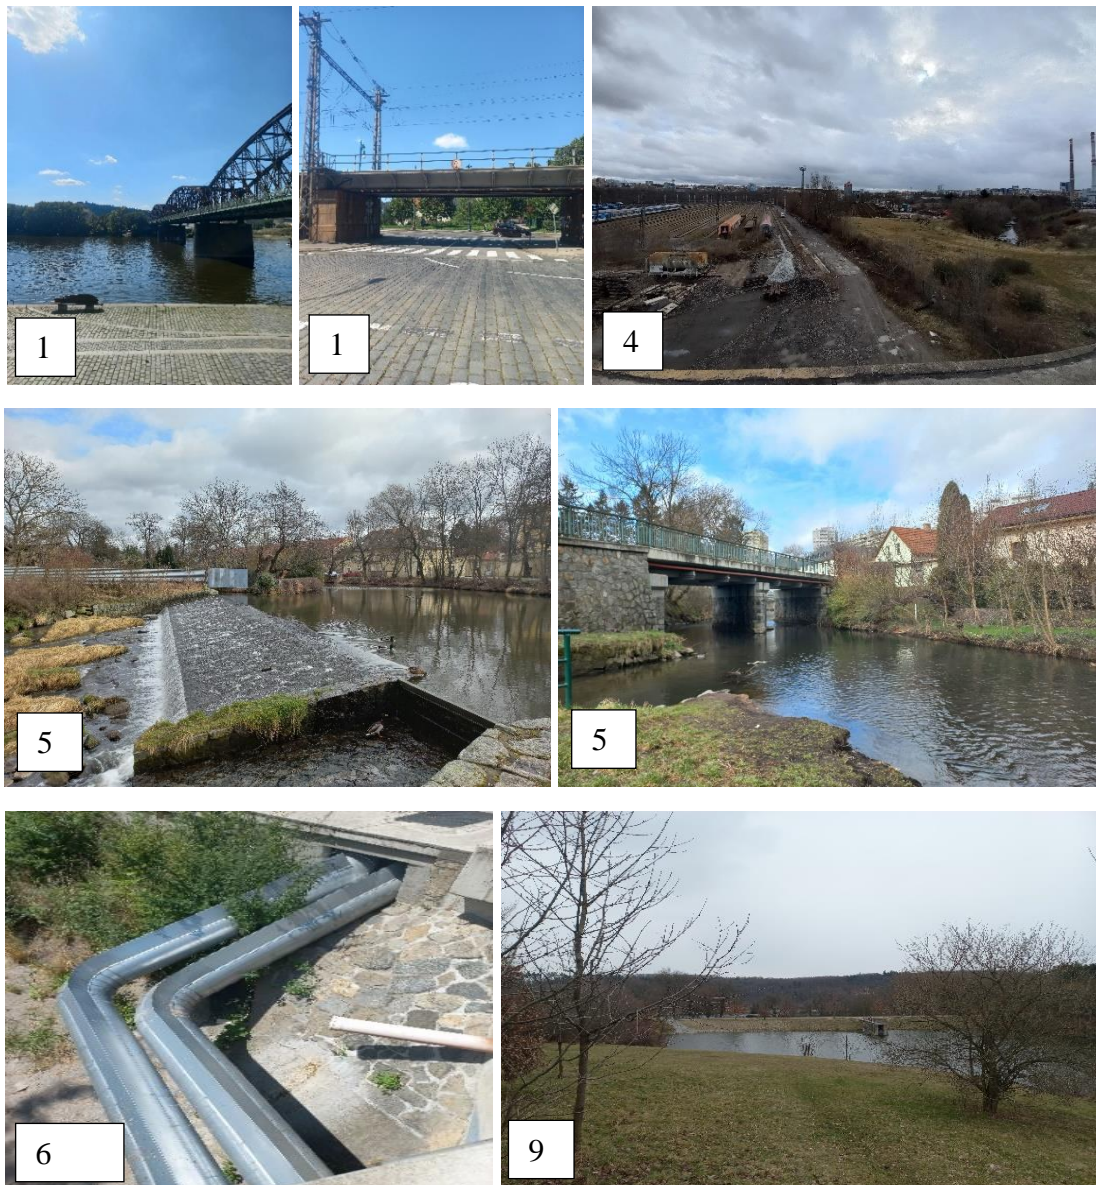
d. Man-made infrastructure and hydrological connection between the watershed and the channel (presence of stormwater drain inlets in the watershed)

The infrastructure includes bridges, weirs, stormwater inlets, retention ponds, viaducts, a train station (the creek flowing in an underground channel), and a waterfront at the confluence of the creek and the Vltava River. The numbers listed in the photographs correspond to the locations marked on the map (**Figure 23**) and labelled in (**Table 10**).

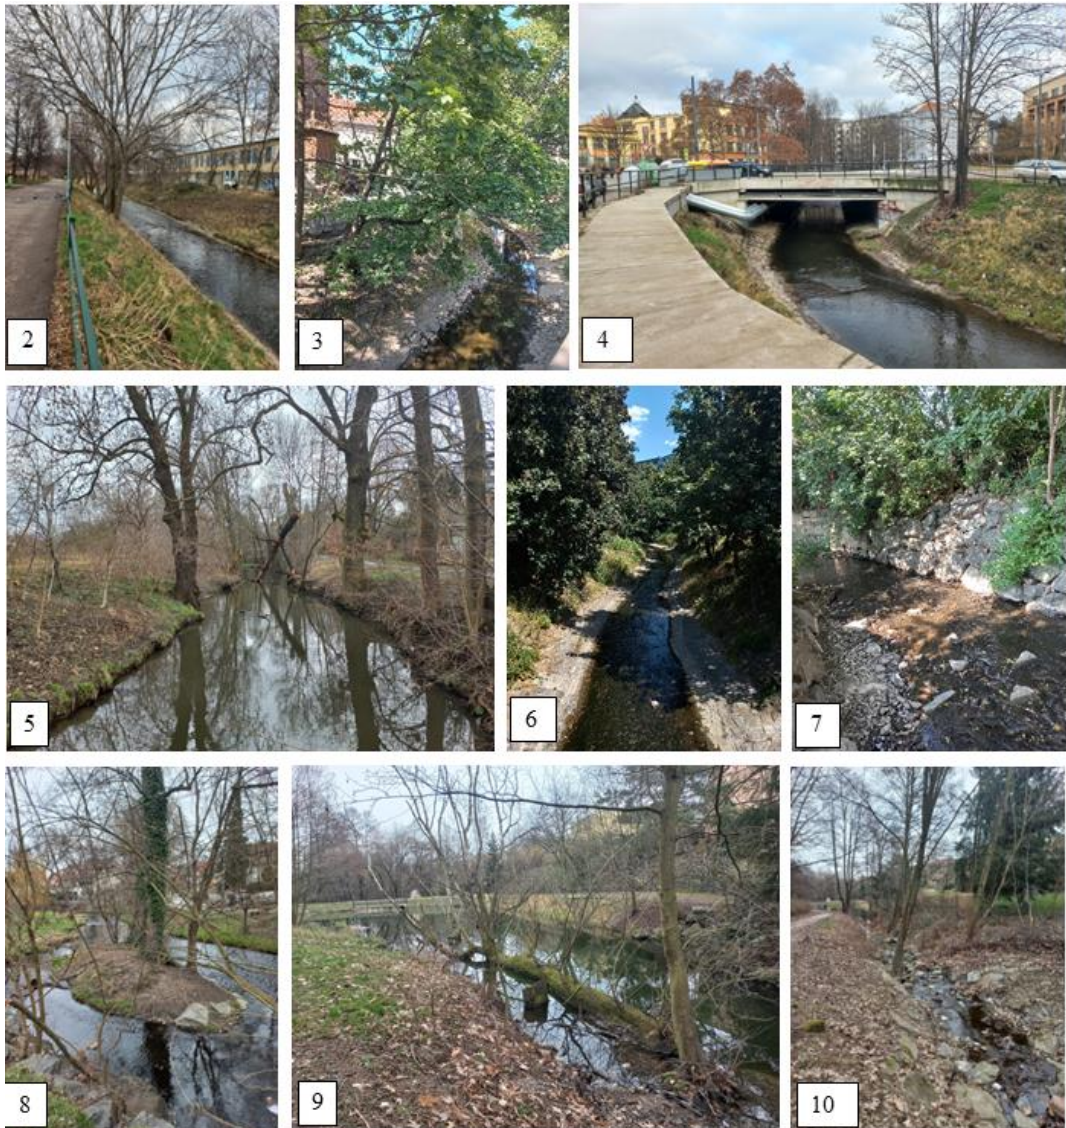
b. Riparian vegetation, presence of dead biota, and shadowing

The images capture these characteristics and observations on the three factors riparian vegetation, presence of dead wood and biota, and shadowing. The numbers listed in the photographs correspond to the locations marked on the map (**Figure 23**) and labelled in (**Table 10**).

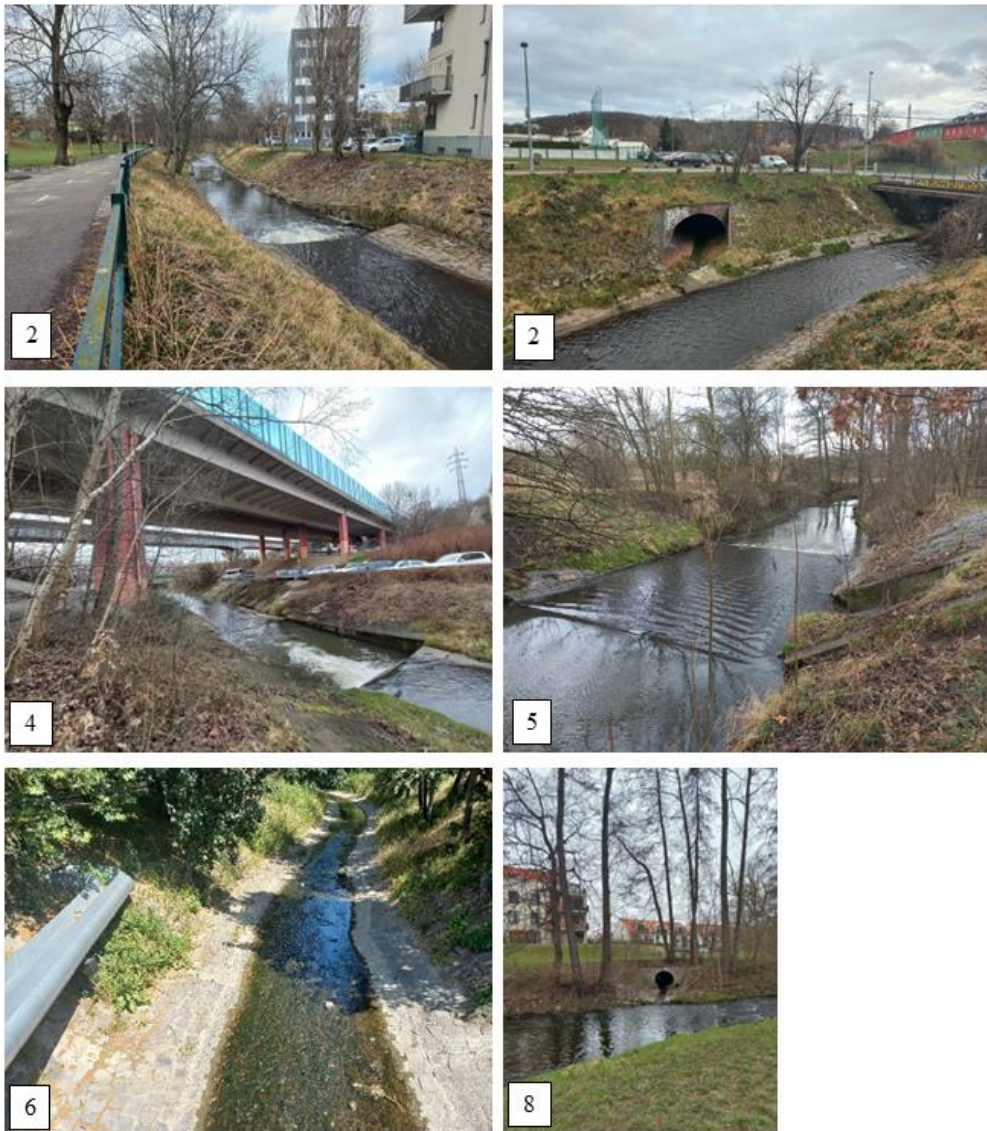
The images capture these characteristics and observations of man-made structures, retention ponds, stormwater drains, and weirs. The numbers listed in the photographs correspond to the locations marked on the map (**Figure 23**) and labelled in (**Table 10**).

At certain locations, the channel was observed to have stormwater drain inlets, retention ponds equipped with dead biota traps, pedestrian bridges, and weirs. Although most streams have been anthropogenically modified and channelized, these specific areas can be classified as man-made structures.

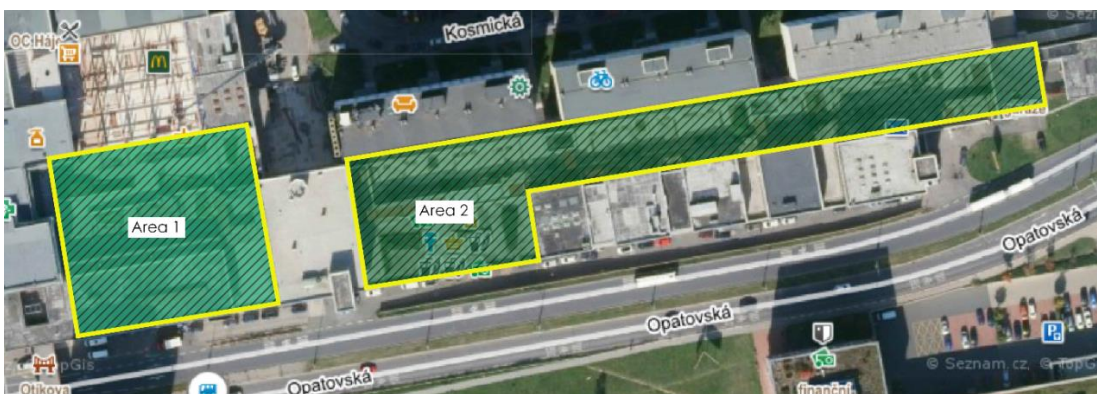
Figure 34. Satellite image of Proposed green roof at Háje metro station. Source: Author

roofs. Háje metro station (Figure 33 & 34) was an example of proposing an extensive type of green roof.

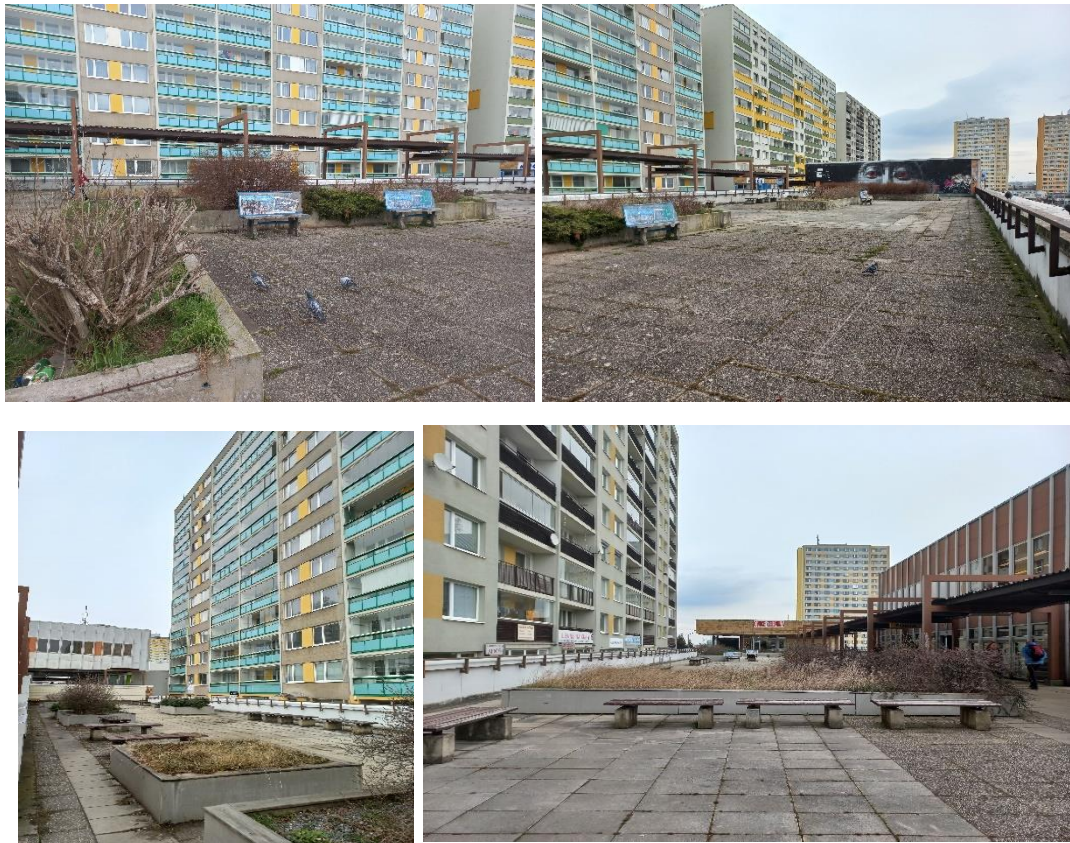
Figure 35. Potential area at Háje metro station for extensive green roof. Source: Author

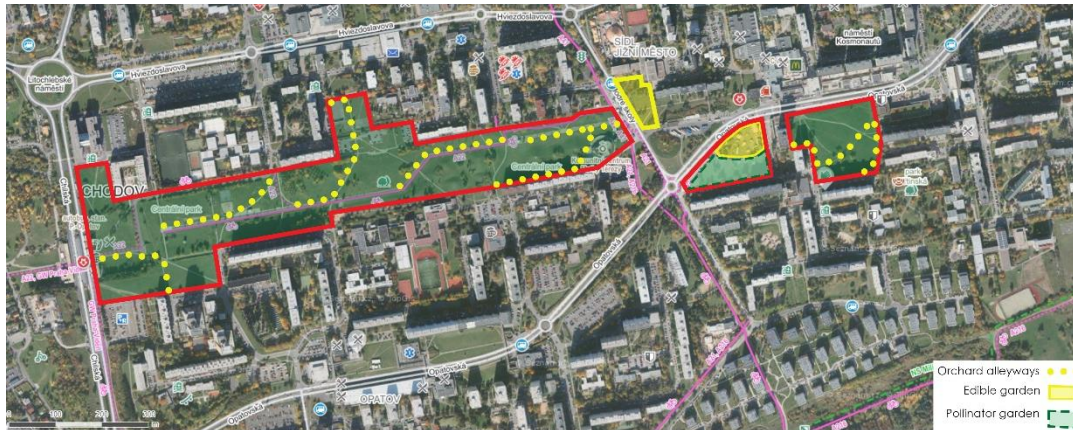
Figure 39. Selected areas of parks and open spaces to represent interactive urban landscape. Source: Author

to engage in multifaceted community activities. Small water bodies can serve as hydrological links, filtering runoff water to prevent it from being discharged into the streams directly while facilitating recharge, water retention, and water purification. The area selected for such a proposal was in the Háje region as an example (Figure 38 & 39).

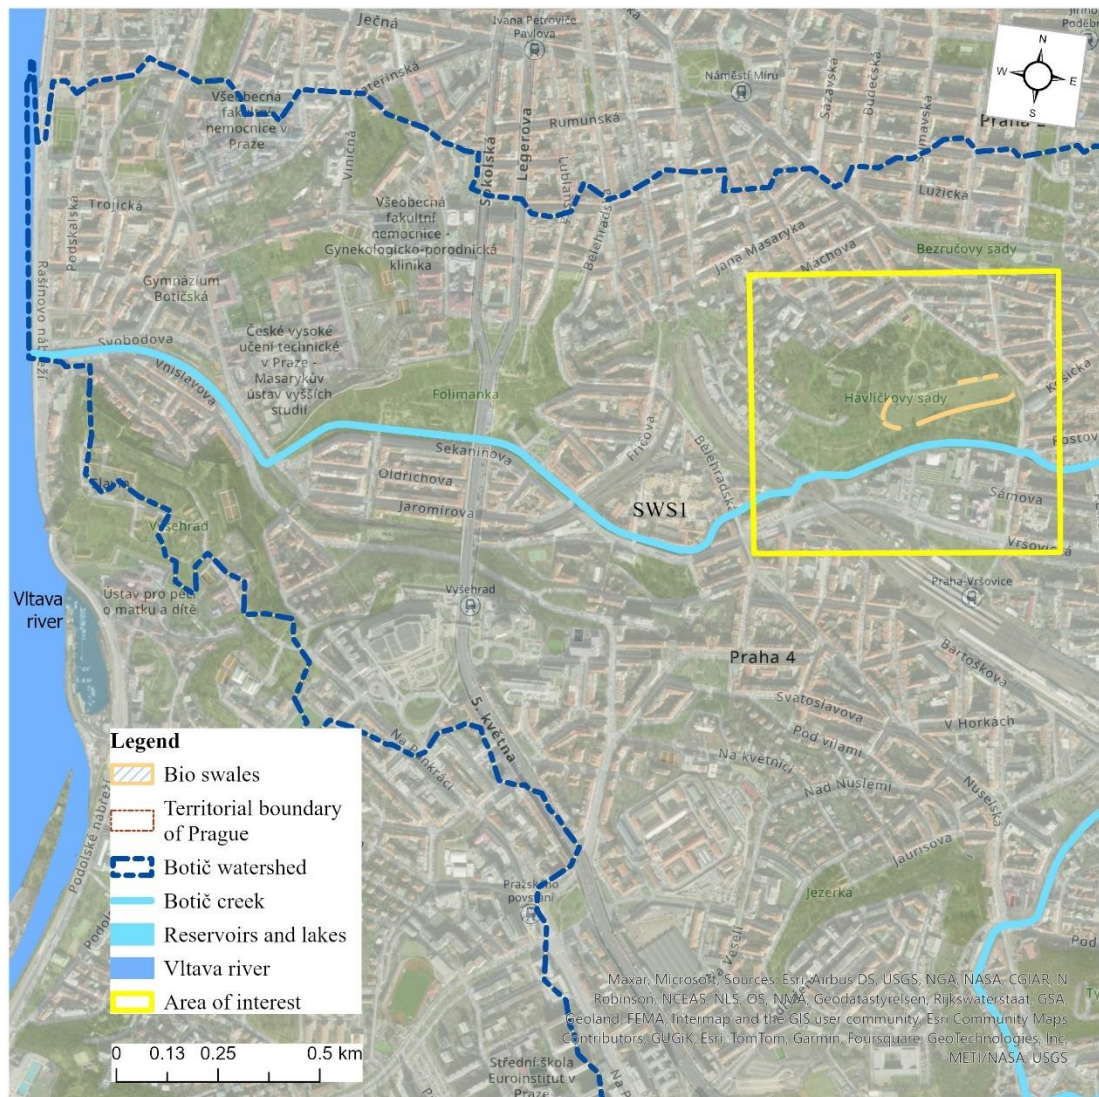
Figure 40. Area of interest for proposed Bioswale at Grébovka Park. Source: Author

The area selected as a typical example having a steep slope that could contribute to polluted runoff water was chosen below the vineyard at Grébovka (Havlíckovy sady) (**Figure 40**).

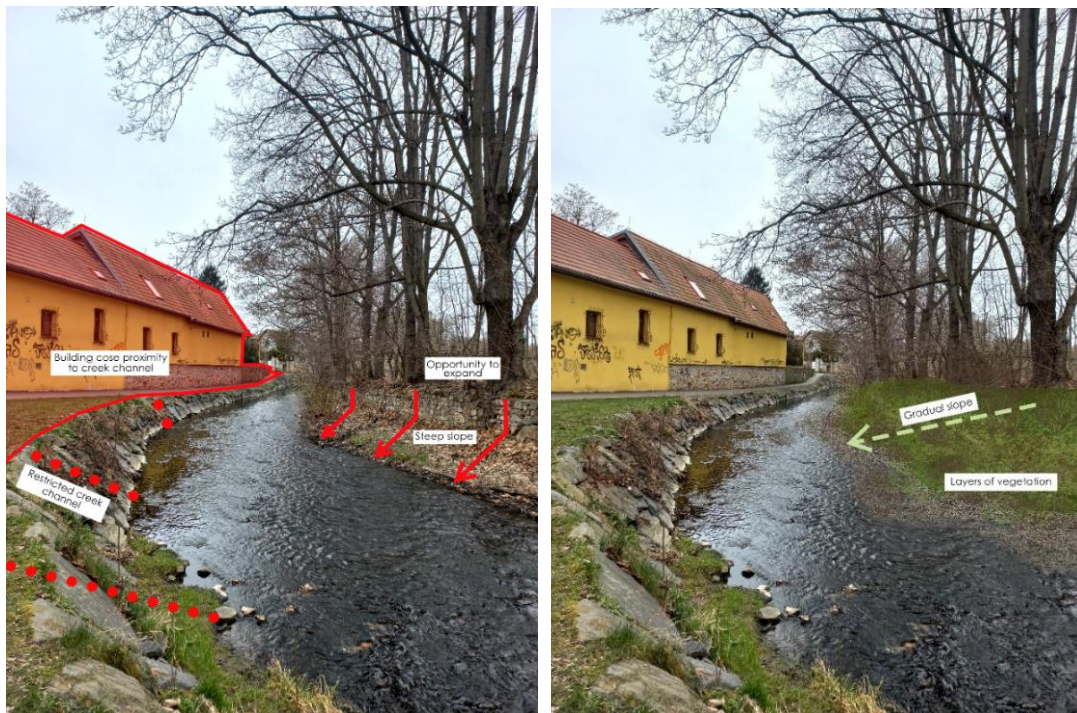
Figure 44. Example 1 – Observed problems at creek channel & Proposed solution close to Hostivařské náměstí. Source: Author

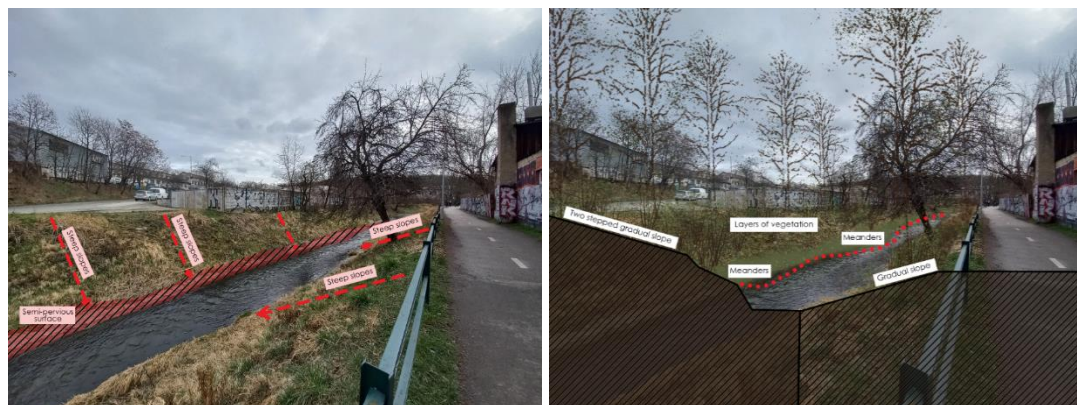
Figure 45. Example 2 – Observations and proposed solution at creek channel close to park Fidlovačka. Source: Author

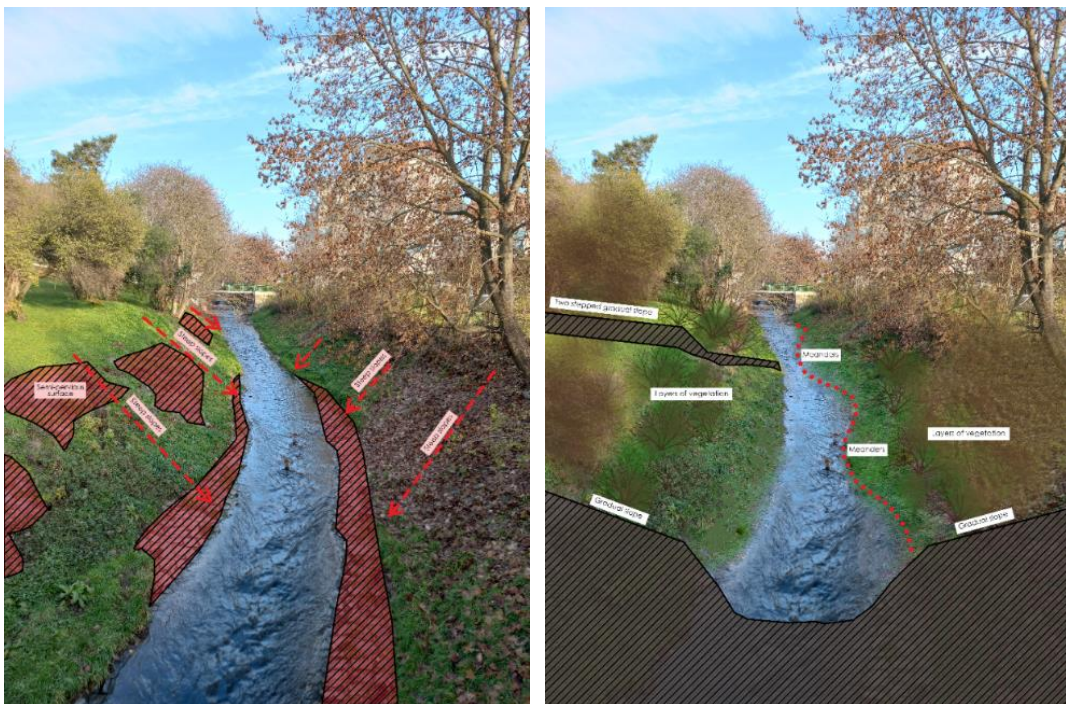
Figure 46. Example 1 – Observation and proposed solution at creek channel between to Grébovka and Folimanka. Source: Author

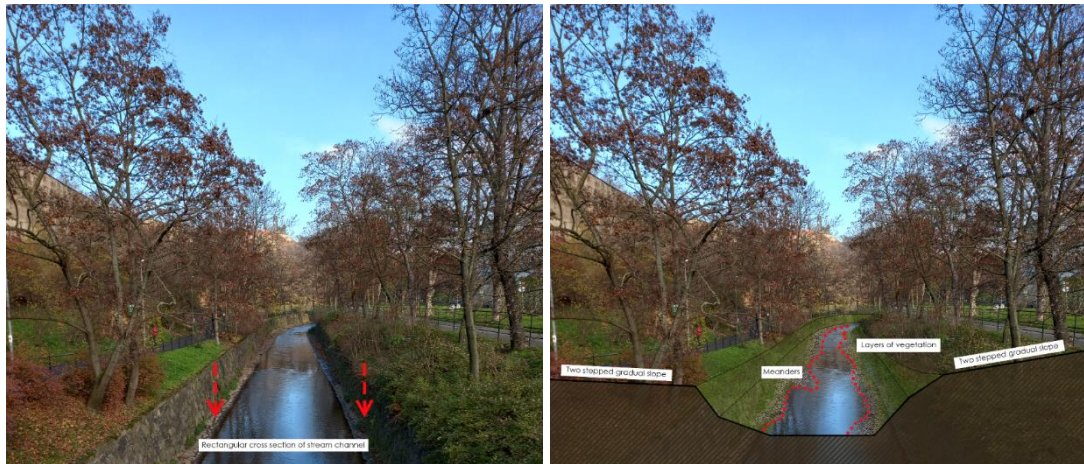
Figure 47. Example 2 – observation and proposed solution at creek channel in Folimanka Park area. Source: Author

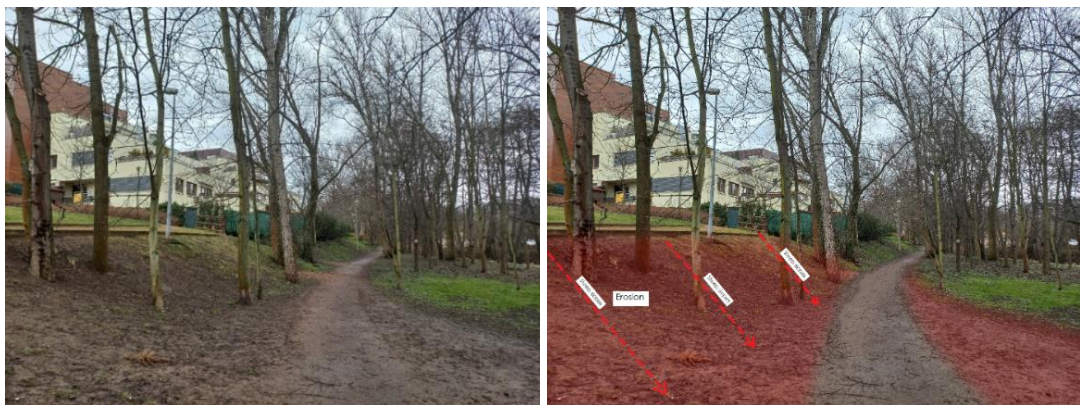
Figure 48. Example 1- Location: riparian zone of creek channel at Záběhllice locality and Erosion at riparian zone of creek channel at Záběhllice locality. Source: Author

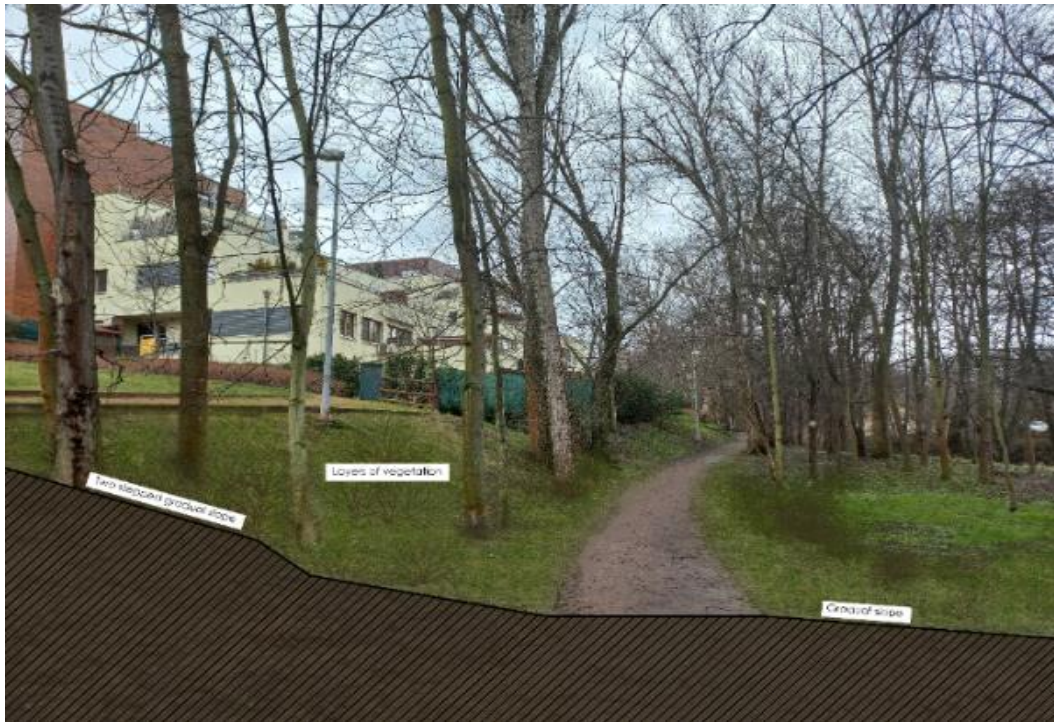
Figure 49. Example 1- Location: Proposed solution for erosion at riparian zone of creek channel at Záběhllice locality. Source: Author

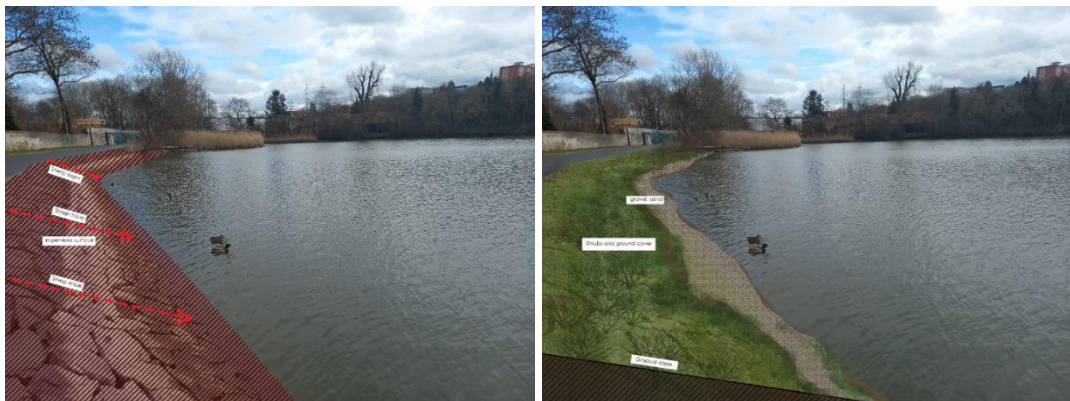
Figure 50. Example 2 – observations and proposed solutions for naturalization at Hamerský pond. Source: Author

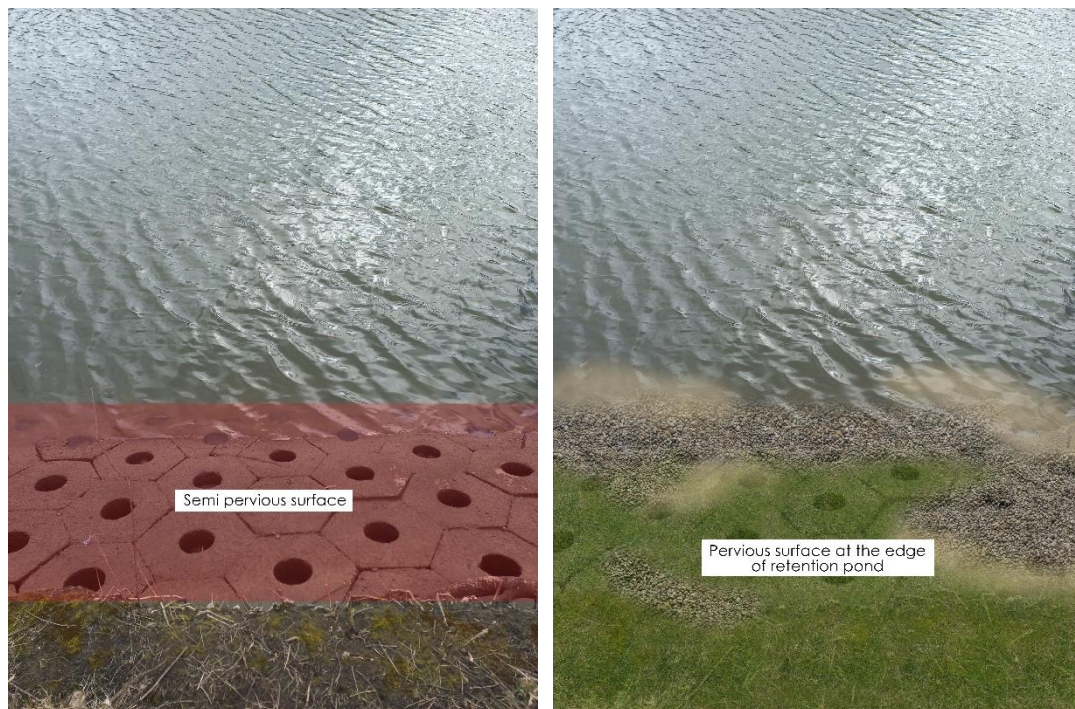
Figure 51. Example 2 – Observation of semi-pervious surface at the pond banks and Proposed solution of textural change, respectively, at Hamerský pond. Source: Author

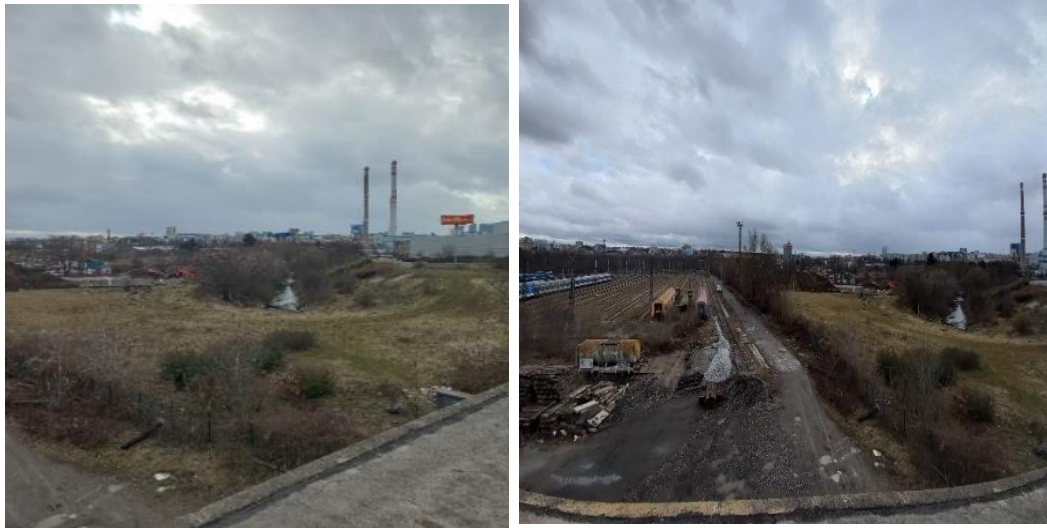
Figure 52. Example 1 - Observations at Michle locality with train tracks and low maintenance. Source: Author

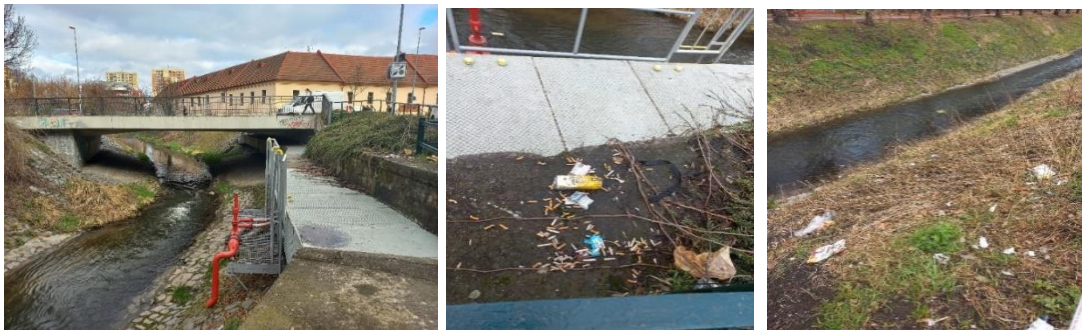
Figure 53. Images documenting observations of littering at various localities. Source: Author

Example 2: Evidence of littering at various locations could be avoided with better education and public awareness regarding the harmful effects of pollution of creeks in urban areas due to human activity. The public would be capable of contributing to the maintenance of the creek channel and watershed level to help improve the ecological status of the creek (**Figure 53**).
