# **Ecohydrological evaluation of a selected small stream and its catchment**

**Master´s Thesis (Joint Degree Programme)**

**Bc. Michal Matys**

8.4. 2016

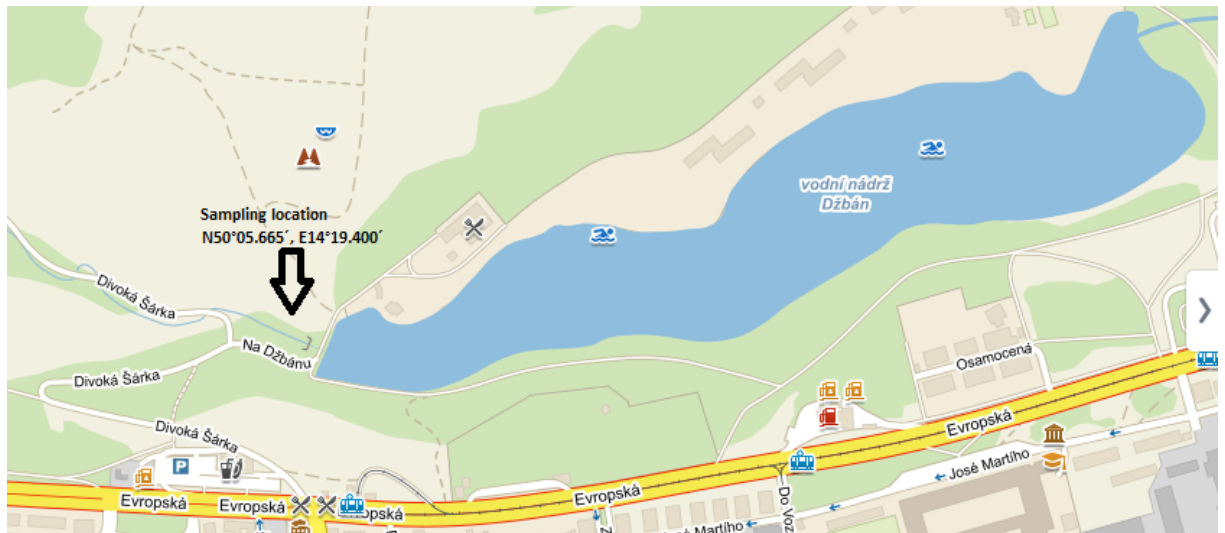
Fig. 7: Sampling location for laboratory testing below Džbán retention basin (Author).

For the reason of one sampling place only, the results of chemical analysis were not included in EcoRivHab evaluation. The data serves for an informational purpose. Obtained readings were not corrected to a certain temperature gradient in order to provide an overview of seasoning changes in hydrochemical properties.

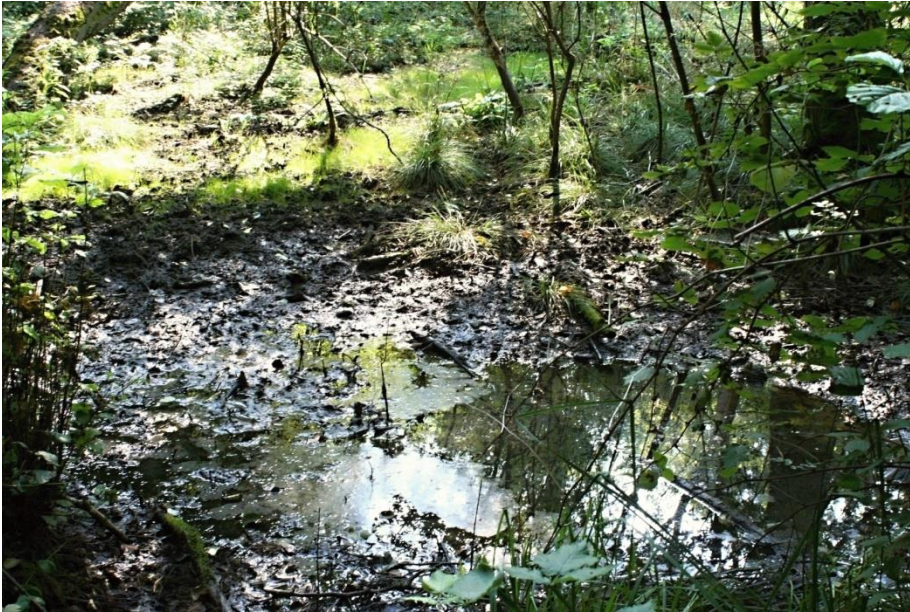
Fig. 20: LIT02 – Reference state for upper part of the stream.

For the upper part of the stream i choose reach LIT02 that represents a location with overall best ranking in upper basin of 1,2. Detailed ecohydrological status of LIT02 is provide in table 11. It is located 1 km west of Chýně municipality. It flows through a dense forest consisting of *Fagus Sylvatica* and few solitary *Carpinus Betulus* species. Its streambed and river banks are not in any way altered. Many accumulation units are present in the streambed and its bottom is fully covered by decaying leafes. Flow dynamics changes between mild and stagnant water that creates large pools. Both left and right sides of the stream are lined with natural forest.

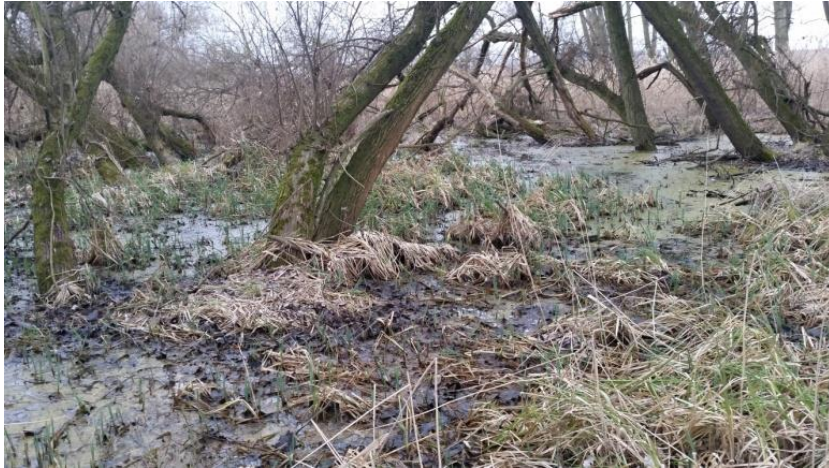
Fig. 21: ZLI03 – Reference state for middle part of the stream.

Part of Zličínský creek was chosen as reference reach . ZLI03 has similar natural conditions as LIT02 and is mainly located in wetland conditions. Although it is situated on a stream that is otherwise qualitatively moderately influenced in both directions (III.ES), ZLI03 gained total ecohydrological ranking of 1,022. Its streambed provides great degree of width variability. Streambed has irregular shape with no alterations. Waterflow is fast and gradually changes into slow flowing water passing through wetland, decaying wood and leafes. River bank is firm and shows no erosion.

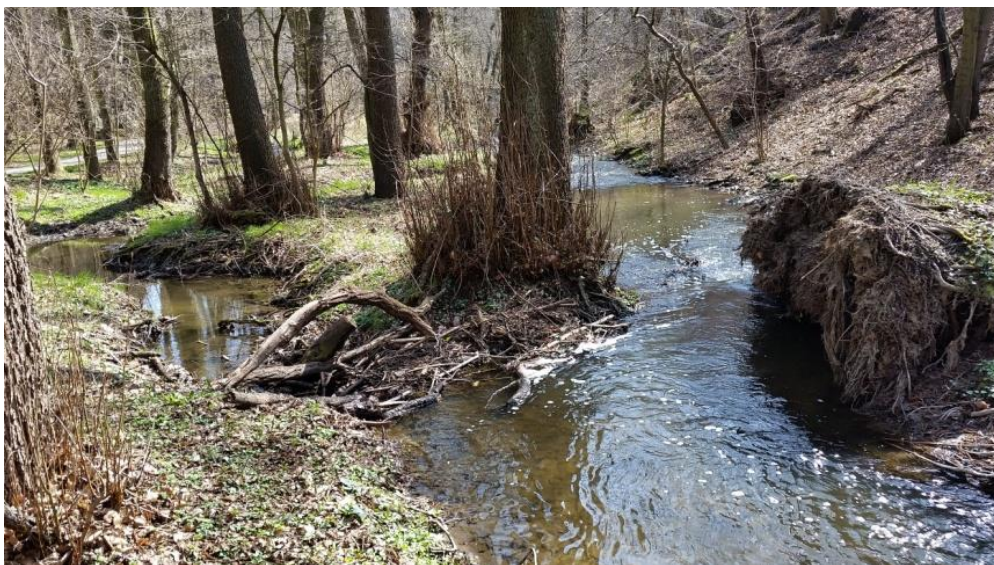
Fig. 22: ŠÁR04 – Reference state for low part of the stream.

For the lower part i chose a refernce reach ŠÁR04 from Šárecký creek. This stretch represents a reference state for the lower part of the basin. Its streambed and river banks are unaltered. Minor riverbank fortifications are present under a wooden and older concrete

bridge. But that is a technical measure, that affects only few meters of total length. The flow is diversified with lots of pools and riffles. There are many oxbows along the way. There is medium amount of wooden debris and couple of uprooted trees that provide additional biological diversity to the habitat. As for the flora, there is *Robinia Pseudoacacia*. It is not native, but introduced and therefore the municipality is currently trying to replace this species with *Quercus Robur*, *Carpinus Betulus* and *Tilia Cordata*.

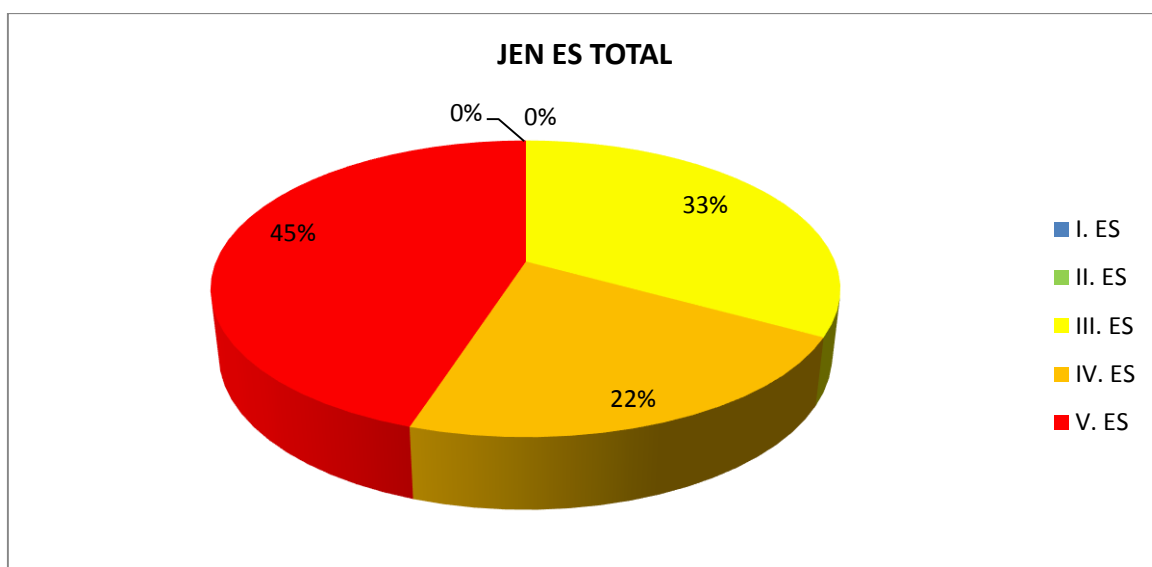
Fig. 23: Ecomorphological state of Jenečský creek – Streambed, Riparian belt, Floodplain

Fig. 24: Ecomorphological state of Jenečský creek – total

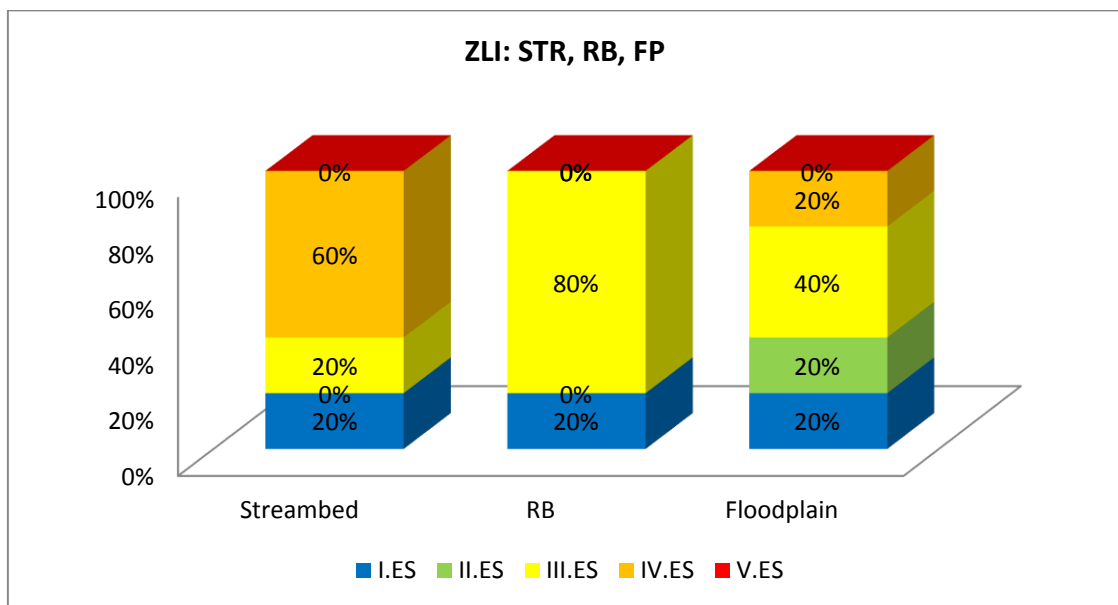
Fig. 25: Ecomorphological state of Zličínský creek – Streambed, Riparian belt, Floodplain

Fig. 26: Ecomorphological state of Zličínský creek - total

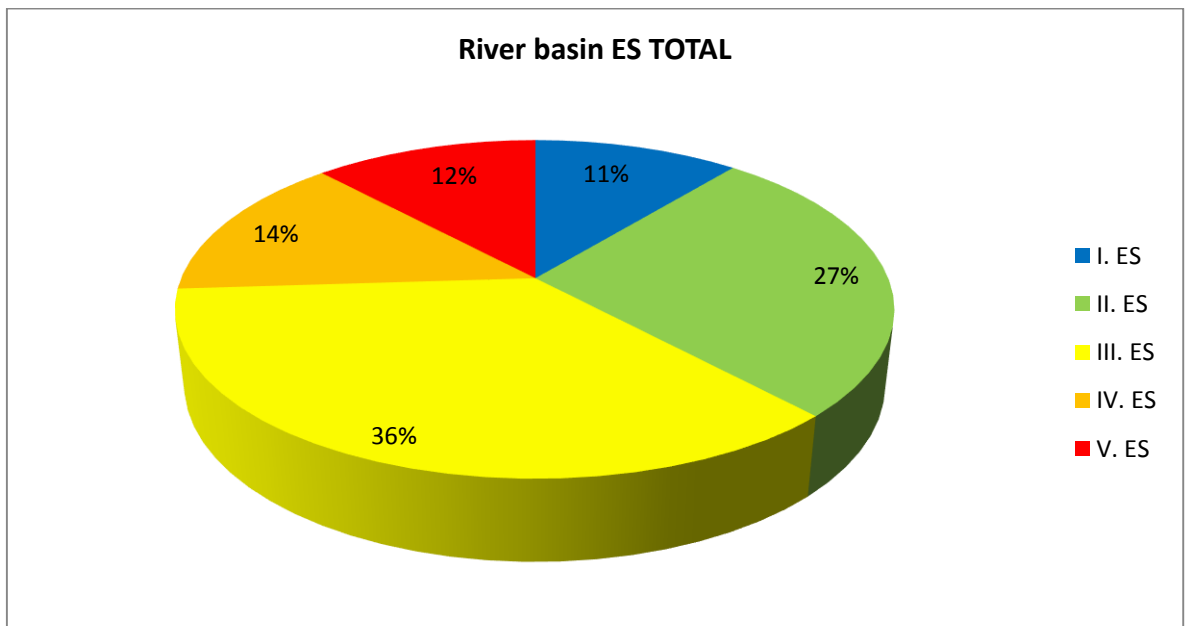
Fig. 33: Ecomorphological state of river's basin – Streambed, Riparian belt, Floodplain.

Fig. 34: Ecomorphological status of river's basin – total.

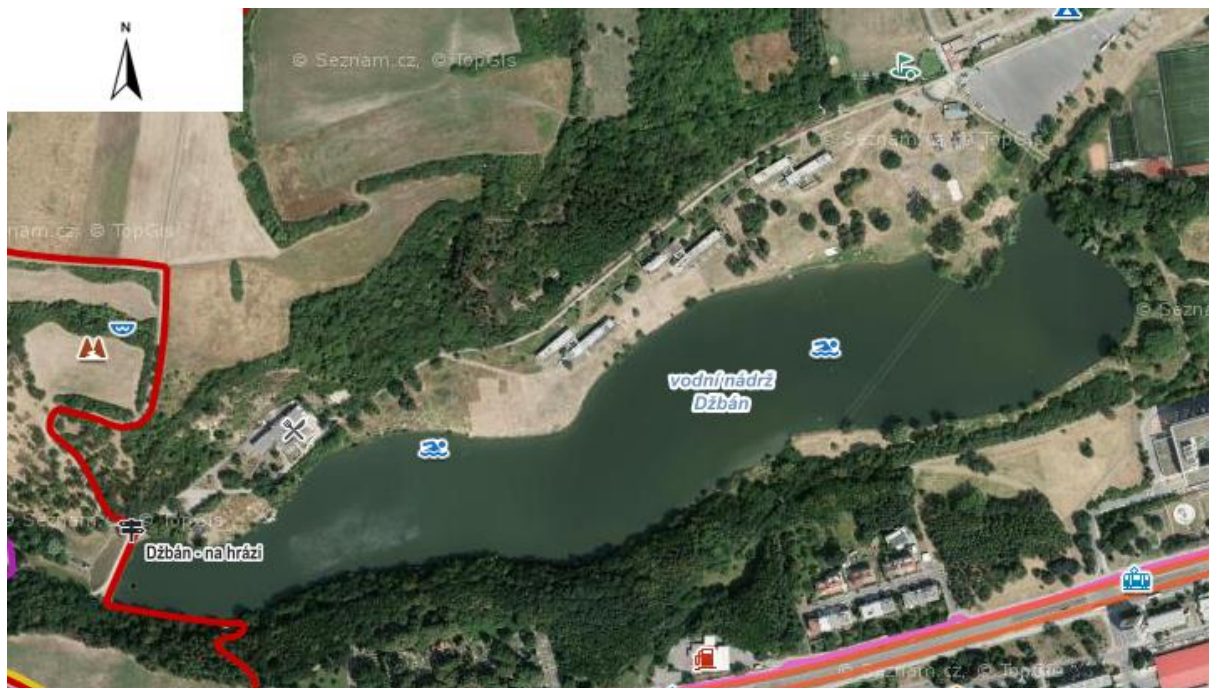
App 2: Current state of retention basin Džbán 2015.

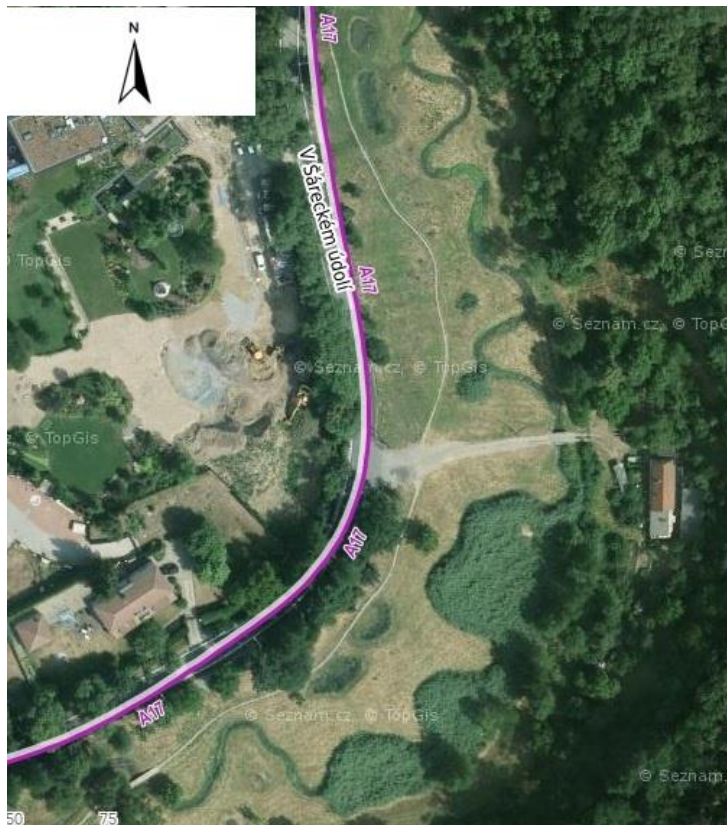
App 4: Current state after revitalization done in 2013 – Kaplanka.
