**Ecohydrological evaluation of a selected
small stream and its catchment**

Diploma Thesis

Author of Thesis: Bc. Katarina Trnovec

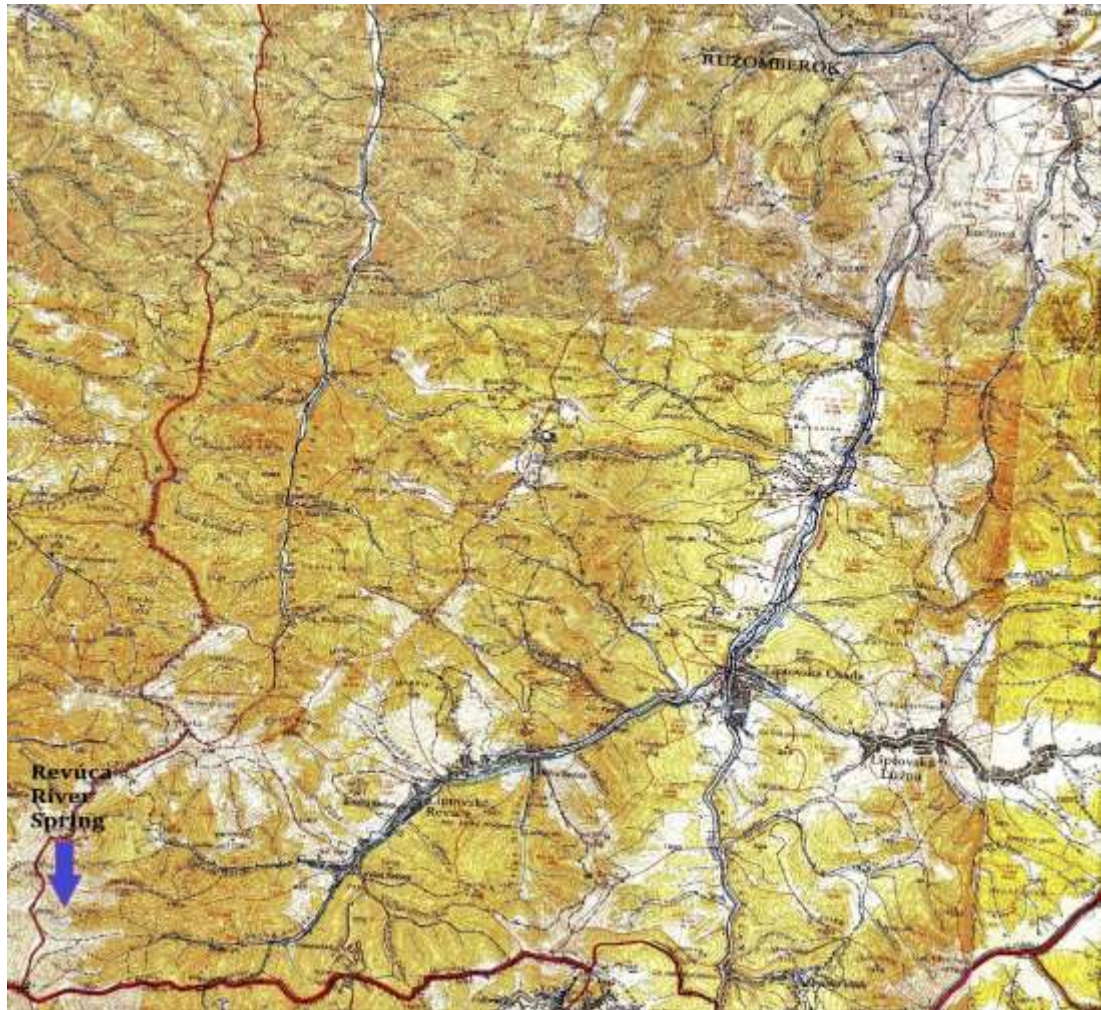
Picture 4. Water management map of the Revúca River with the location of the spring marked (Slovak Water Management Office, processed by the author)

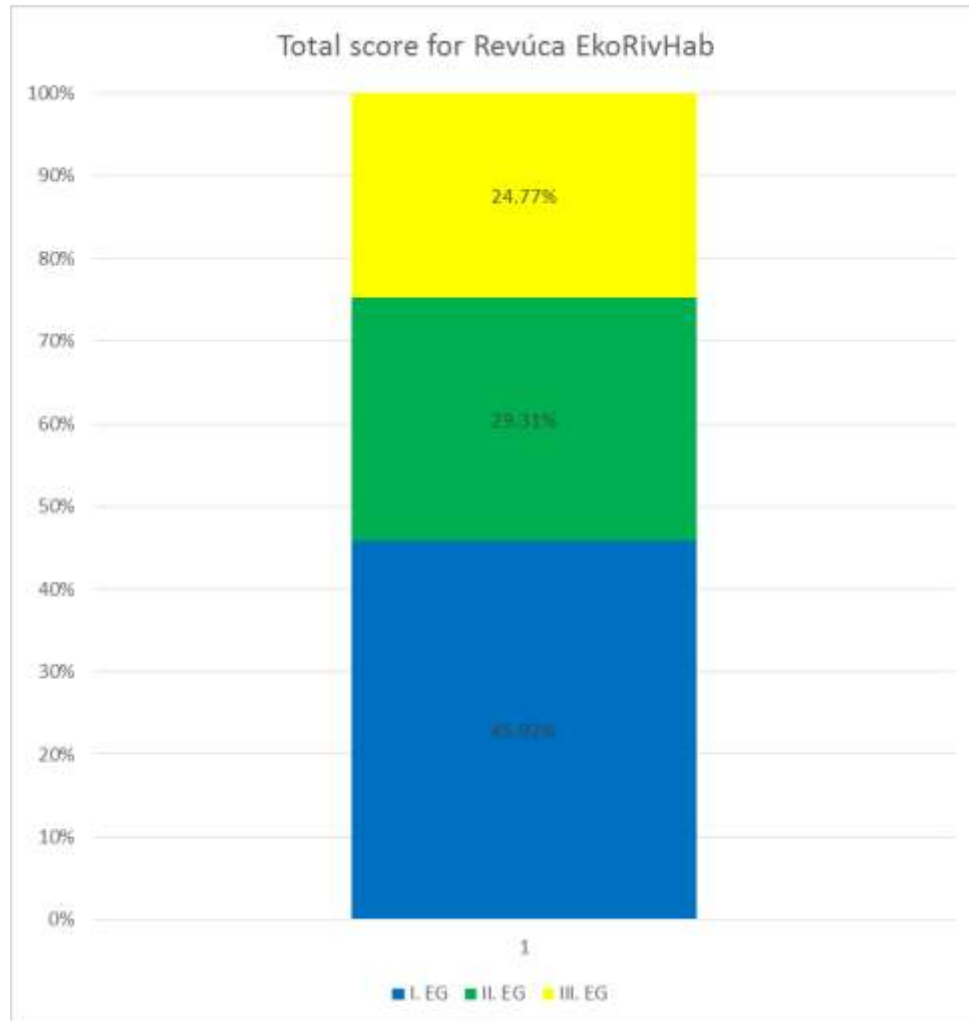
Graph 1. The overall EcoRivHab ecomorphological score for the Revúca River

The total EcoRivHab ecomorphological grade of the Revúca River is II. About one half of the river length is in very good ecomorphological conditions. This means that, although there are some parts where the river needs to be restored or revitalized, the overall condition is very good and the Revúca River can be called as being only slightly anthropogenically modified, in mostly natural conditions.

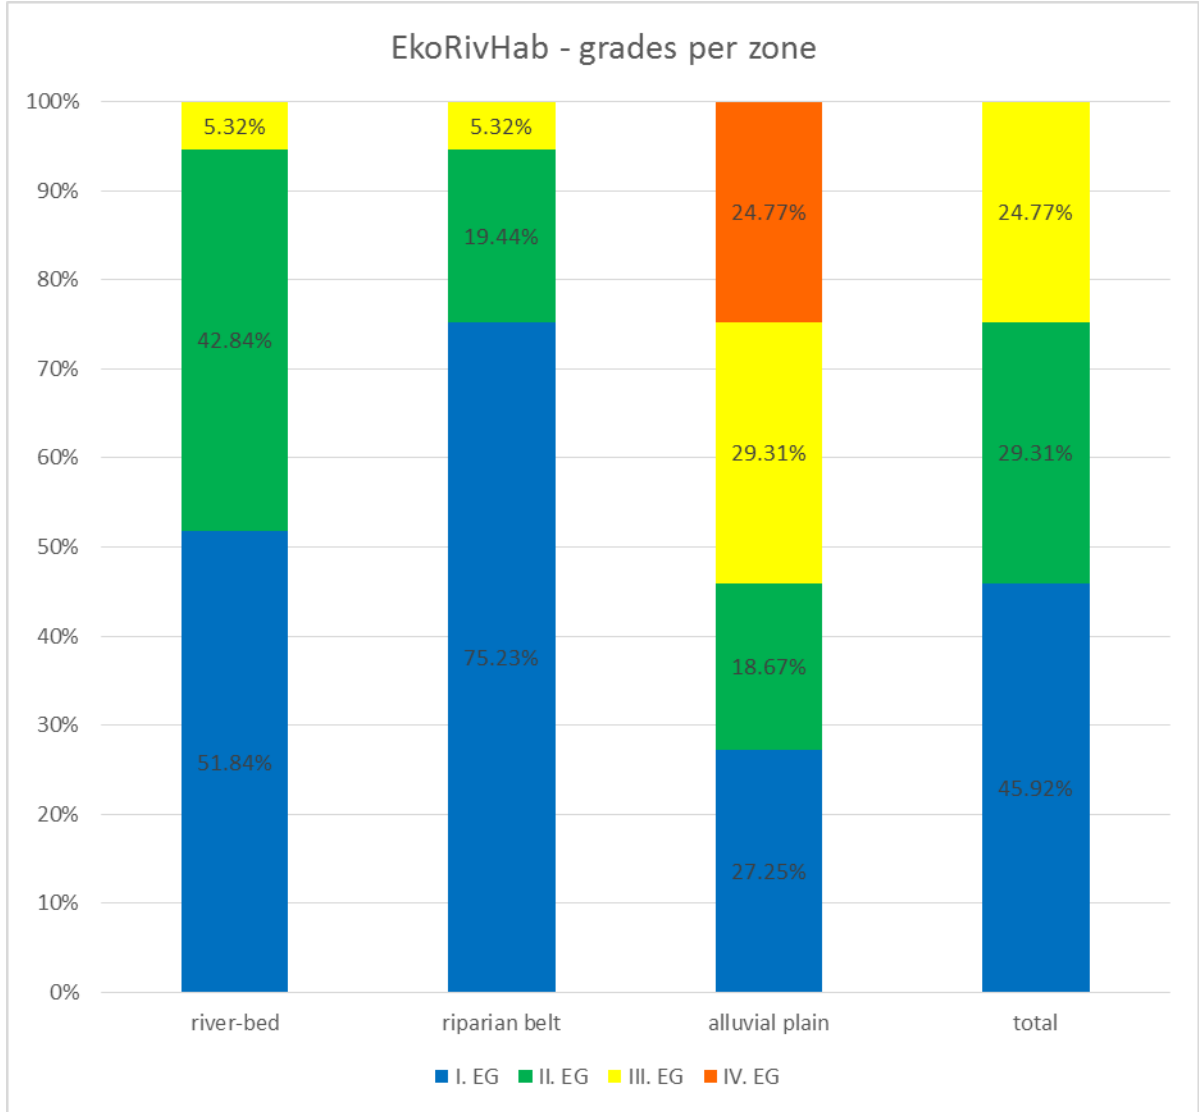
Graph 2. Ecomorphological EkoRivHab grades per zones

Looking at particular zones of the landscape around the river gives somewhat different and more heterogeneous results. The riparian belt of Revúca River is the best valued one, followed by the river-bed zone. The worst rating has the alluvial plain. This was awaited as the river flows thru highly urbanized areas.

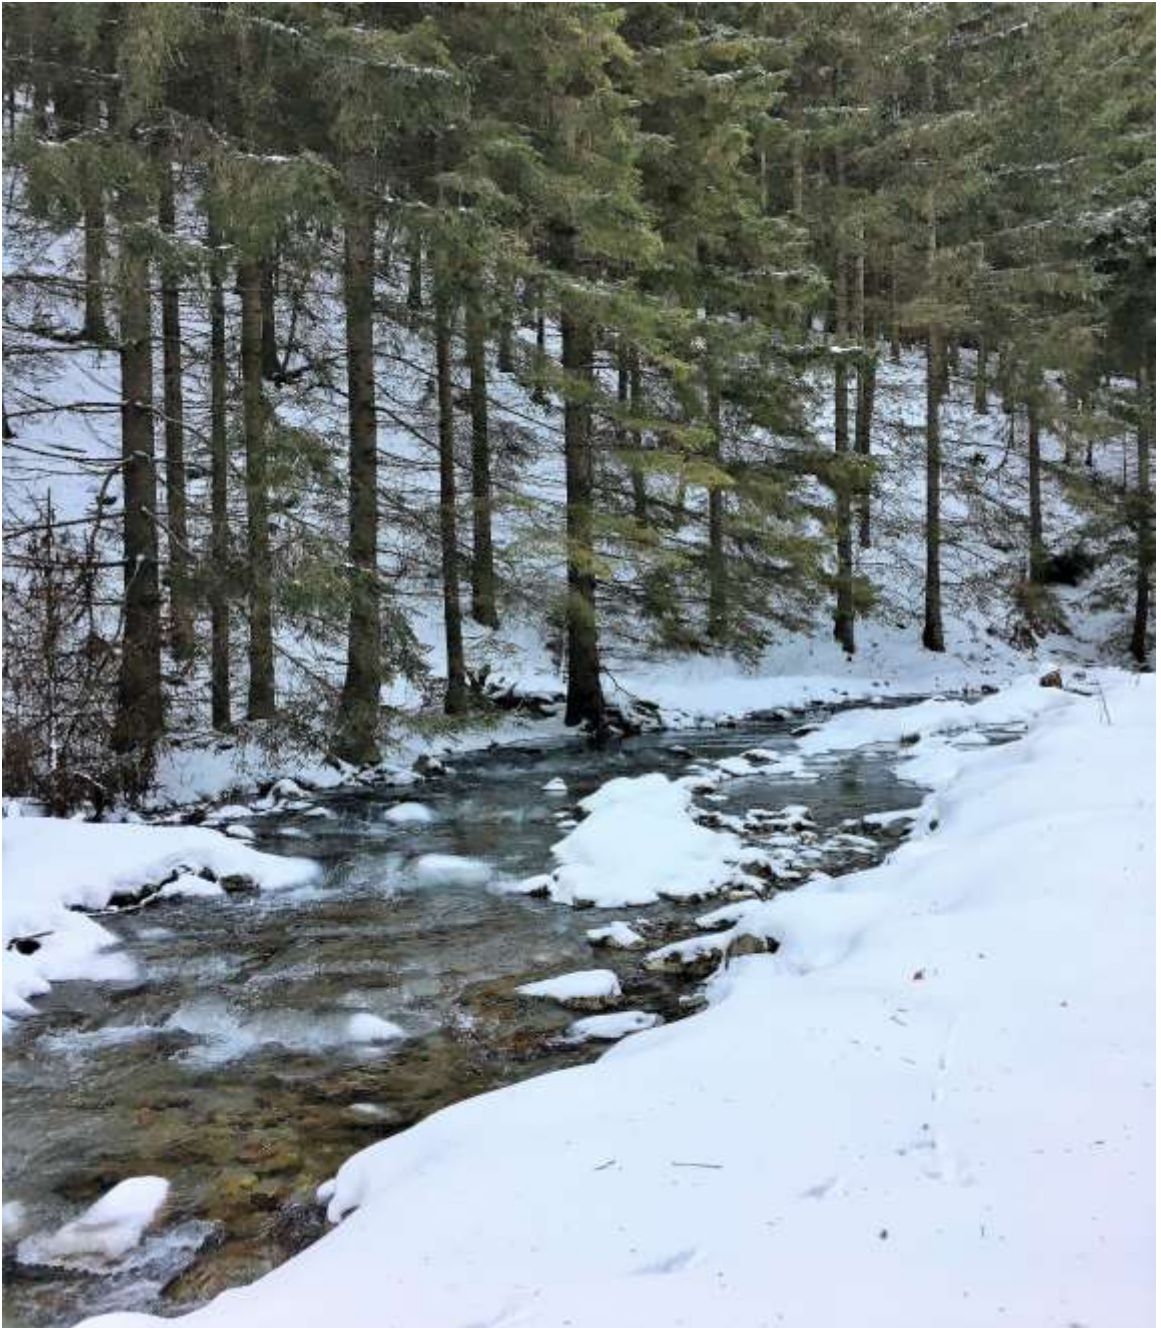
Picture 5. RE03 Reference section

The section RE03 with an overall ecomorphological grade I was chosen as a reference section. This section finds itself in the area where the river discharge increases due to

some small creeks joining the Revúca. The river is passing here through a partially urbanized area along a major communication route. However, the river-bed zone is not modified by any structures. The stream-bed is natural with gravel, cobbles and stones. There is high variability of flow along the alternating riffles and pools. The riparian belt is composed of meadows, pastures and forest. Regarding the whole alluvial plain, even though there is a road, this never comes close to the river, so that the flow is not modified. The whole valley is very nature-friendly and idyllic for its scenic views.

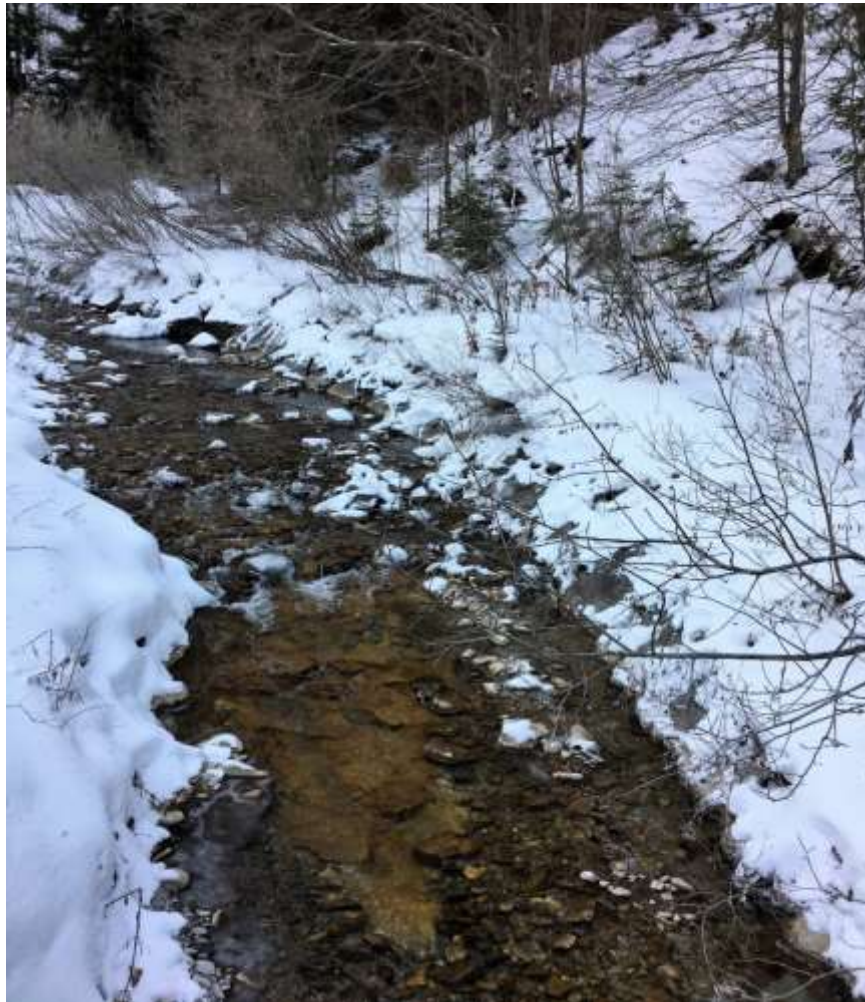
Picture 6. RE01 section where cobbles sustains river-banks underneath one of the bridges

The first section RE01 starts at the very beginning of the Revúca River at its spring on the south-east hillslope of Ostredok (1592 m) as a torrent creek made out of three small streams. It quickly comes to a valley surrounded by forest, composed mostly of spruce (*Picea abies*). Rock outcrops are present both in the forest and near the stream creating natural curves. The valley has very wide bottom overgrown with small trees, fern, burdock, wild grass and other vegetation for mountain streams. The river bed width is variable. There are places where the stream looks wilder, being very narrow, and places where the river bed is wider and creates small pools. In the valley there is a mountain trail and, therefore, there are several wooden bridges crossing the creek, where the river bank is stabilized by stones and concrete. This stone fortification is partly destroyed on some places because of the stream water impact. There is a side creek there joining the Revúca stream. The tributary creek is conducted through a tube underneath a culvert over which the trail is lead. In winter, this tube becomes partly blocked by accumulated ice, broken tree branches and leaves. What happens in this case is that their lateral creek overflows the banks next to the trial and creates a small pool. On both sides of the valley there is a compact forest with some rock formations. The overall ecomorphological grade is I and is the same value for the river-bed, the riparian belt and the alluvial plain.

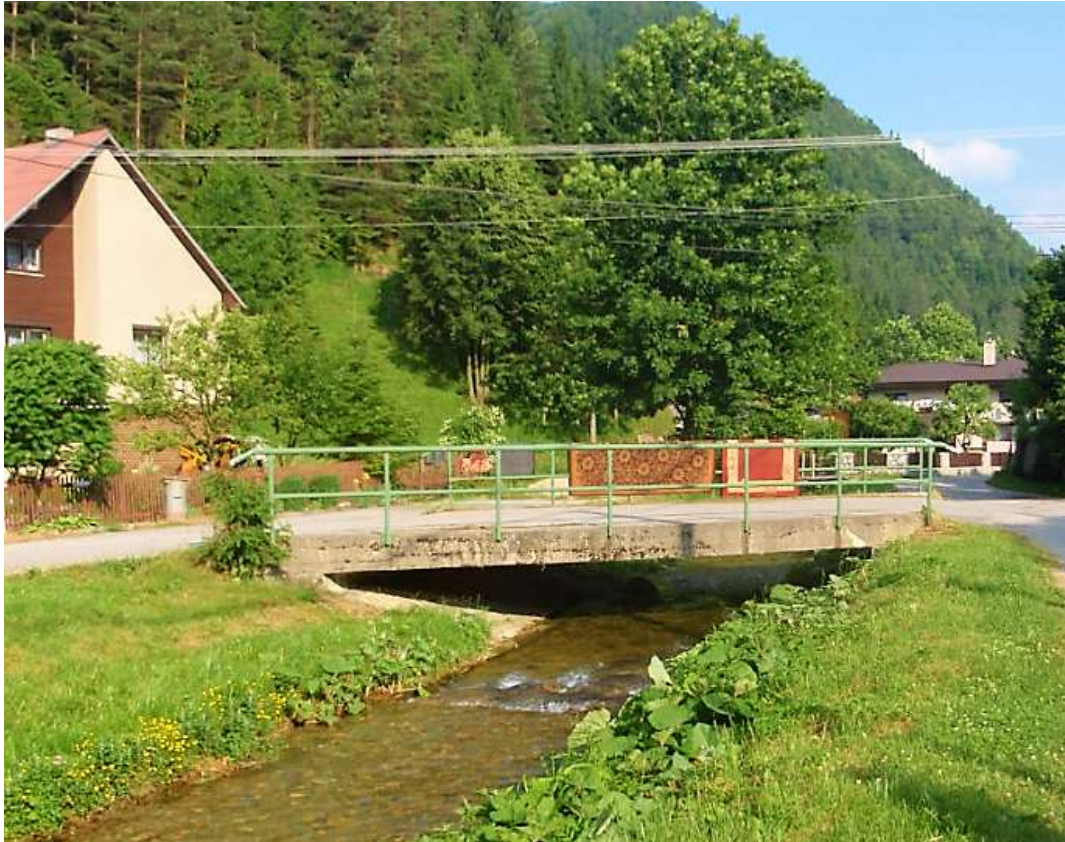
Picture 7. A typical concrete river-bank fortification around a bridge in the E02 section

The second section RE02 starts in Liptovské Revúce, a small but very long town alongside the still quite small Revúca River. The town layout is “Y”-shaped, where the long side lies next to the Revúca River and the other, branching part surrounds the Suchý Vrch Mountain (1550 m). The town has 3 parts called the Upper, Middle and Lower Revúce. The river, as well as the town, are located on the bottom of a valley. A part of the valley bottom is used as pastures and small fields. The Revúca River is mostly on the left side of the town. The other river bank is accompanied by forest that continues upslope in the south-east direction. The river has been partly modified by humans, mostly due to artificial river bank fortification and the stream narrowing. The river bank fortification is made of stones bound by cement mortar, so that the final look is as if it were made of concrete blocks. On some places, the water stream broke the concrete and the disintegrated stones fell inside the river, but otherwise the river-bed is not modified.

This river-bank fortification was done partly by public institutions and partly by people from the village. The fortification mostly affects the river-banks only and not the bottom of the river. Therefore the river-bed ecomorphological grade was taken as II, as well as the riparian belt. The alluvial plain consists of urbanized areas mixed with forest and meadows. Its ecomorphological grade is IV. The total ecomorphological grade for this section is therefore lower, compared to RE001, namely, grade III, as there are only small parts of the stream where the natural state is visible.

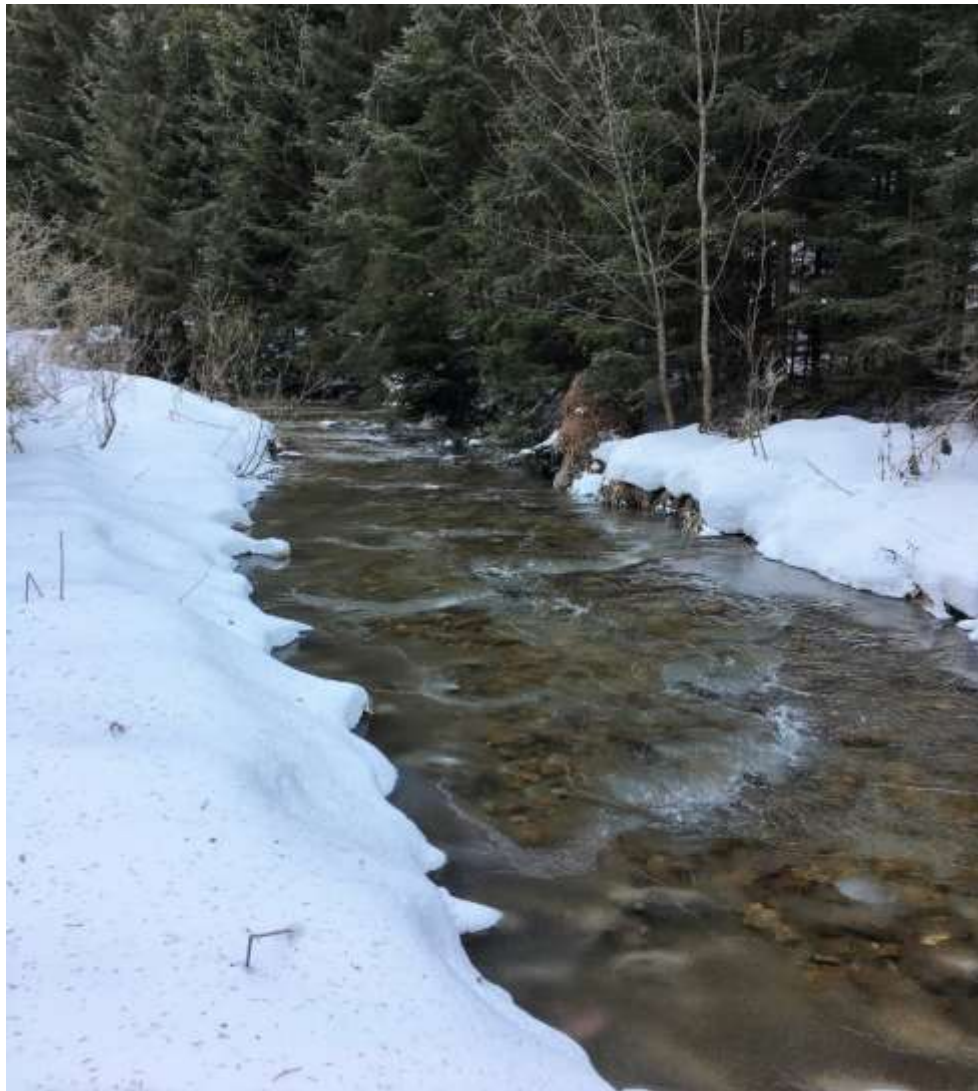
Picture 8. Typical RE03 section area in winter

In the third section RE03, which is also the reference section, the Revúca River follows the valley that has relatively wide bottom (20 – 150 m). The river is surrounded from both sides by forest, in some parts there are tree alleys. The ecomorphological grade for the riparian belt as well as for the alluvial plain is I. There is a road connecting Liptovské Revúce and Liptovská Osada with some crossings of the river via bridges, but mostly the road is placed at higher elevation, compared with the river, which flows on the bottom of the valley. In the parts, where the river is surrounded by tree alleys, the riparian belt is used as pastures with solitary trees. The river-bed is in its natural unmodified state and is rated as the Ith EG. After reaching Liptovská Osada, the river changes its direction from north-west to north. Even though there are some small river bank modification in this section, the total ecomorphological grade is I.

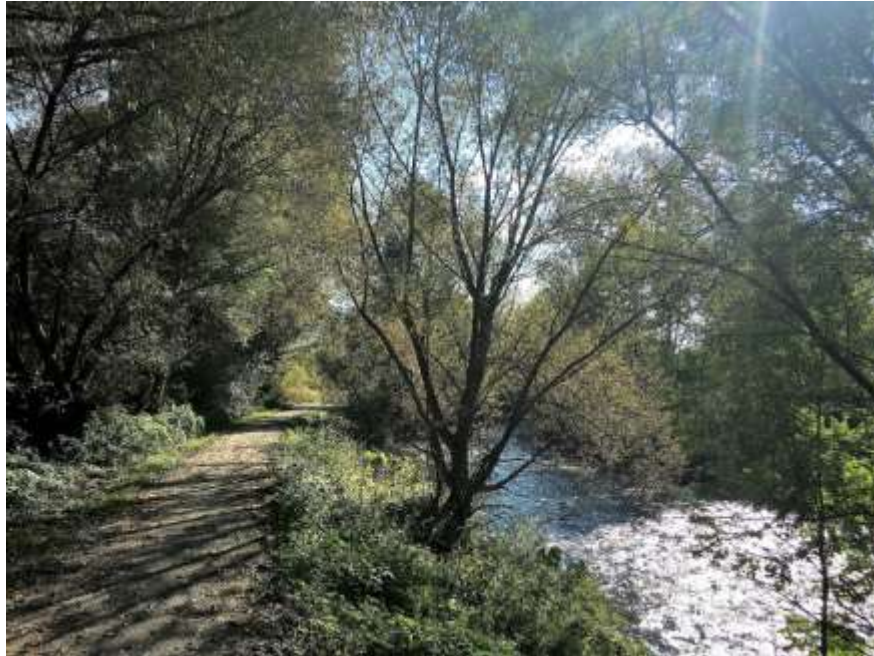
Picture 10. Section RE05 with bicycle road Cyklokorytnička

In the section RE05, the Revúca River flows in a wavy way and creates a natural border between two nature reserves, Nízke Tatry (Ďumbier, 2043 m) on the left (east) side and Veľká Fatra (Ostredok, 1596 m) on the right (west) side.. As the valley is wide, the road is not always located directly next to the river. The stream bed is not modified and flows in small curves. Its ecomorphological grade is I. In the part of Podsuchá there is small fortification of the river bank done. There is also an inlet to the gauging station for measuring the river discharge and the physical and chemical properties of water. Further downstream there is a fish company having an inlet channel from the river. This company also provides the whole river with young fish for increasing the fish populations. Depending on the stream discharge and the month, they can take in up to 1.5 m³/s of water. As for the riparian belt, the most frequent arrangement here are tree alleys that have gone a bit wild over the years and nowadays create an almost total protecting cover of the stream. The alluvial plain is composed of some urbanized areas and a motor-highway leading toward Ružomberok. The ecomorphological grades for the riparian belt is I and for alluvial plain it is I. The total ecomorphological grade is I.

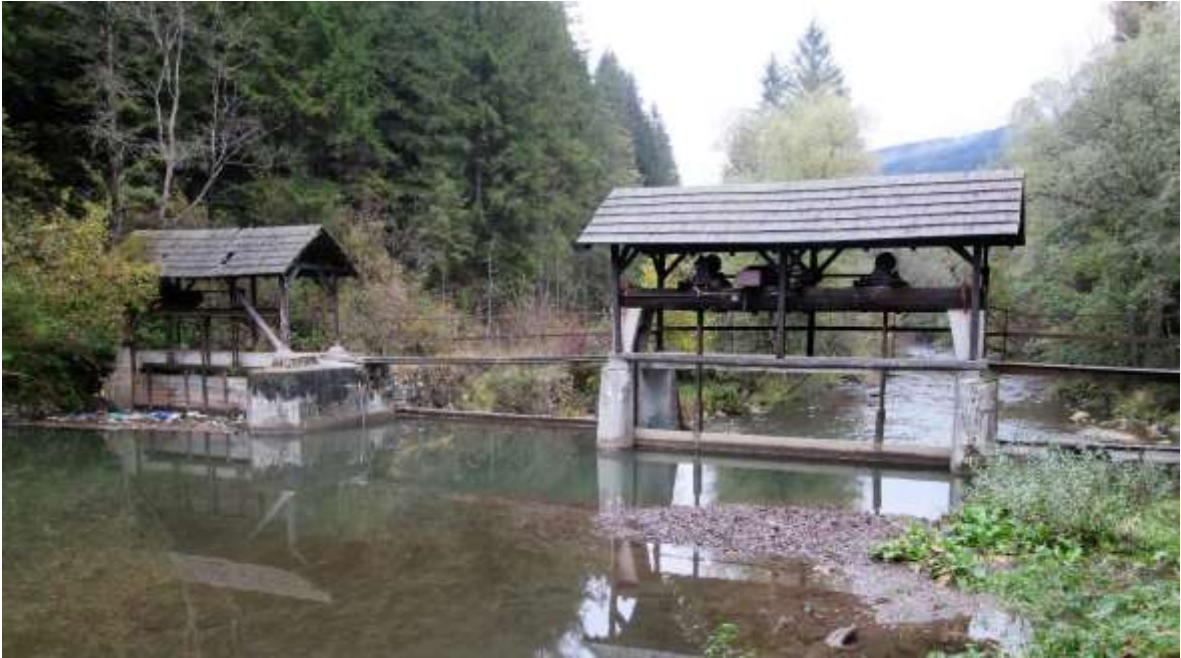
Picture 11. Historical water gate (weir) viewed from the upstream side at the beginning of the RE06 section

Next section, RE06 begins in a historical water gate (weir) with another hydro-electric power station. On the left side of the water gate, there is a water inlet for the power station. The water gate, when open, does not present a migration block. However, when the discharge is low, the gate has to be closed, so that the owner of the power station can take enough water through the turbines. There is a project in preparation for a regular fish migration path on the right side of the historical water gate. The construction should be realized in forthcoming years. Downstream of the water gate, the streambed is wider and shallower. After entering Biely Potok village, the stream becomes slightly modified, but the modified parts are not so many and the river mostly follows its natural wavy path, the same as in previous sections. The riparian belt is typically grown over with trees or meadows, although there are parts where the river flows next to houses of Biely Potok village. Its ecomorphological rating is I. The river banks are partially fortified with stones. This fortification was done 30-40 years ago and is rarely recognizable today, as

the grass, small trees and water flow remodeled the area. The river-bed as a whole is given the Ith EG. The section ends with a recently modified riparian belt, where a new playground and bicycle path have been established. The alluvial plain has a worse grade (IIIth EG), as it is a mixture of urbanized areas, gardens, highways, alleys and other similar land use types. The total ecomorphological grade of the section is II.

Slovak Water Management Office is preparing a project of a new migration path for the water gate in RE06/REV002 section. The project is now in engineering development process, as there are many complications. One of them, but a very crucial one, is the water discharge as there are two companies allowed to extract water from the stream. Therefore, the expected realization of the project is so far unknown.

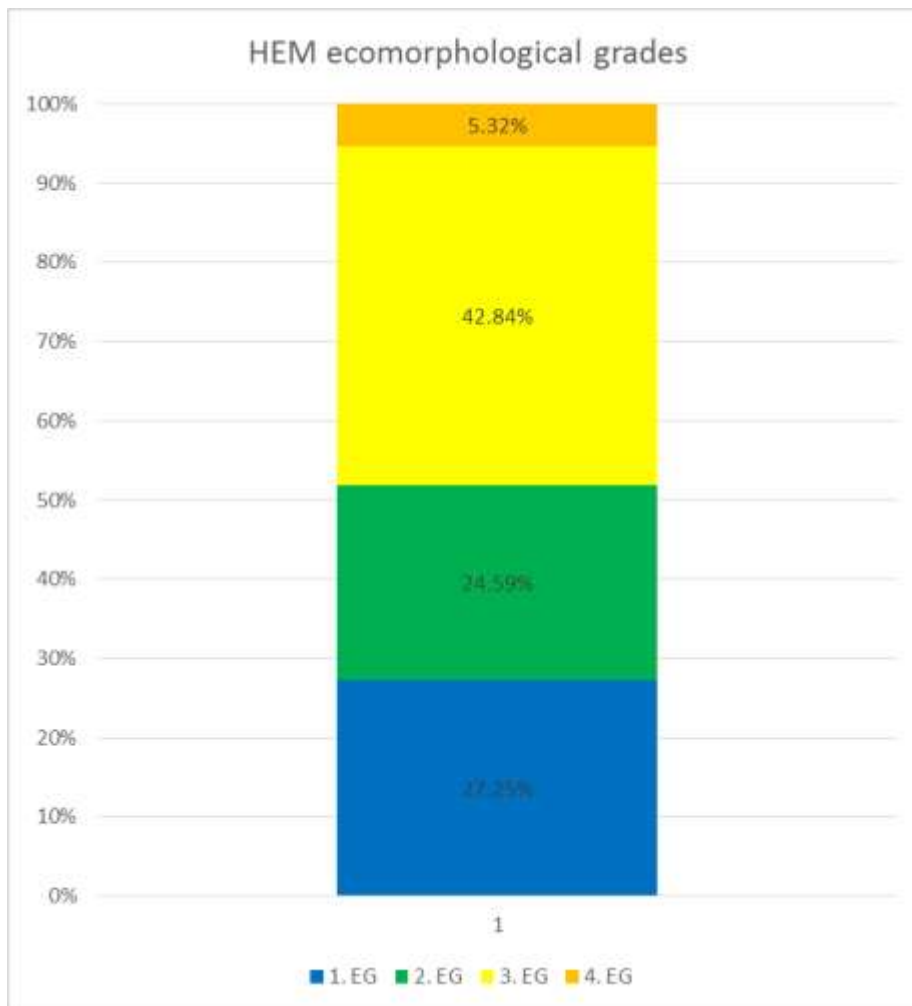
Graph 3. Total score for the Revúca River using the HEM method

The total ecomorphological score using the HEM methodology is 2. EG, which is interpreted as a slightly modified river. The evaluation shows that something more than a half (51, 84%) of the Revúca River is close to nature close or in slightly modified conditions, while the rest (48, 16%) is medium or largely modified. It is a positive outcome that the largely modified part makes only 5, 32% of the total river length and not more.

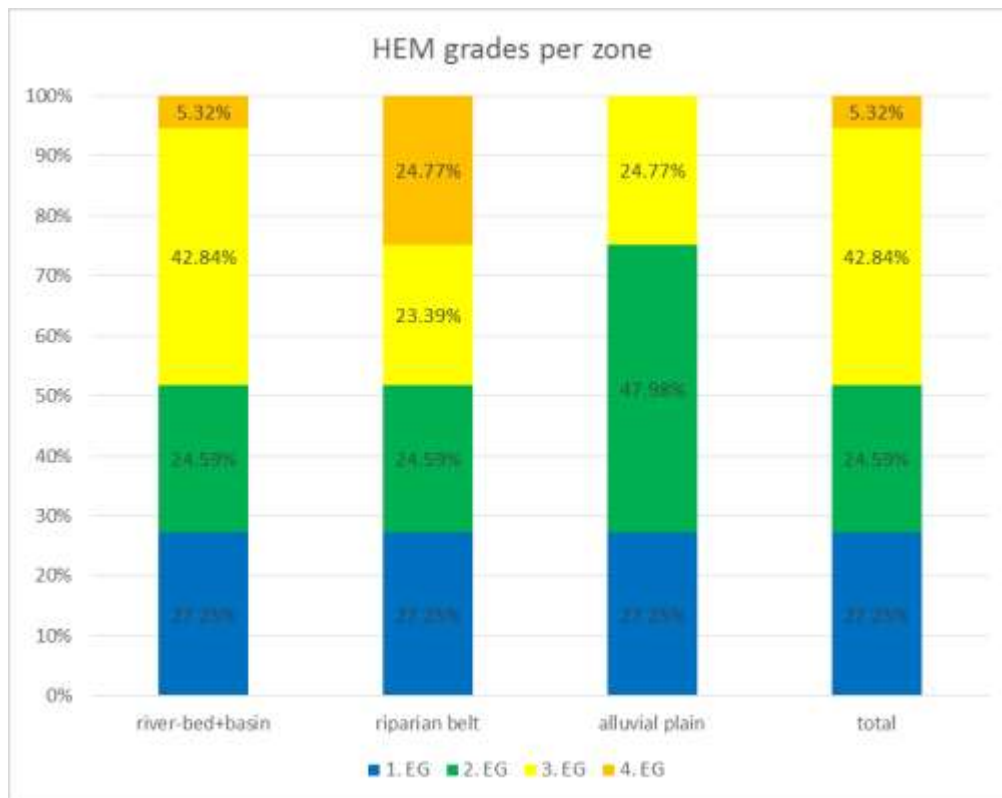
Graph 4. HEM Ecomorphological grading per zones

As per particular zones the ecomorphological grades vary more. The best graded zone according to the HEM methodology is the alluvial plain. Its grading is obtained from the alluvial plain land use, the flood plain throughput and the river bank stability and its ability to move. The second best zone is the riverbed zone. Although there is some diversity in the grades of this zone, as the fourth ecomorphological grade also appears in this zone, the majority of the sections is evaluated as nature close or slightly modified grade. The riparian belt of the Revúca River is the more heterogeneous. This is also because HEM evaluates the river-bank modification as part of this zone and there are some forms of the river-bank fortification present in many sections of the Revúca River.

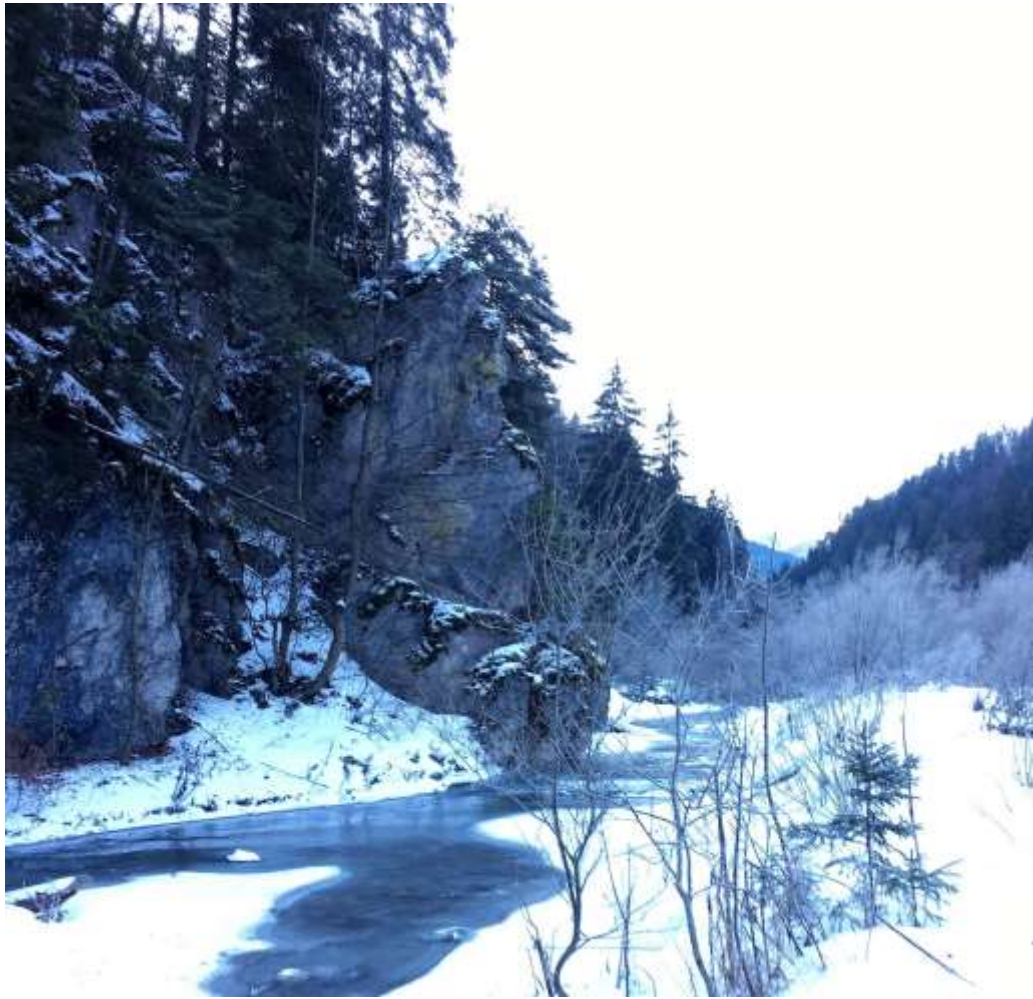
Picture 13. A typical view of the REV_007 section with 1th EG value according to the HEM methodology

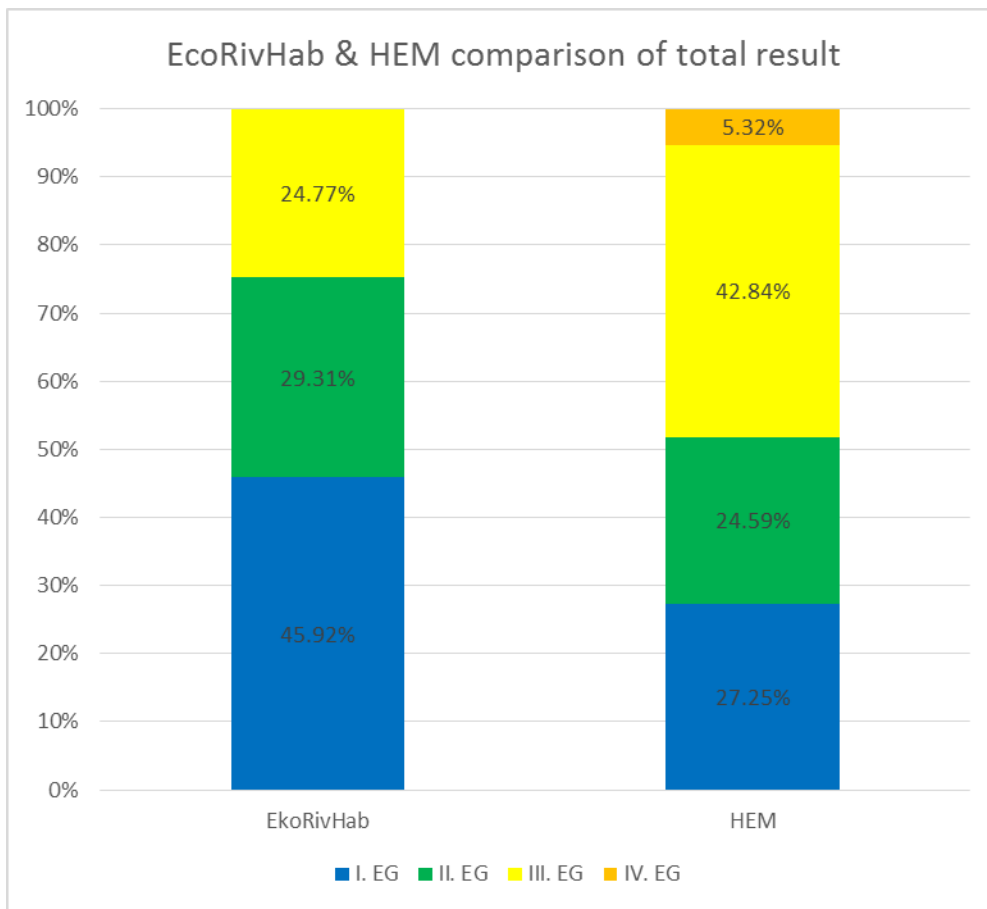
Graph 5. Comparison of results between the EcoRivHab and HEM methodologies

On the above graph, it is very easy to see that the results of both methodologies are different to some extent. This is mostly caused by different approaches and also by different parameters recorded. However, the final summary result of the ecomorphological grading is the same for both methods, being IIth EG.

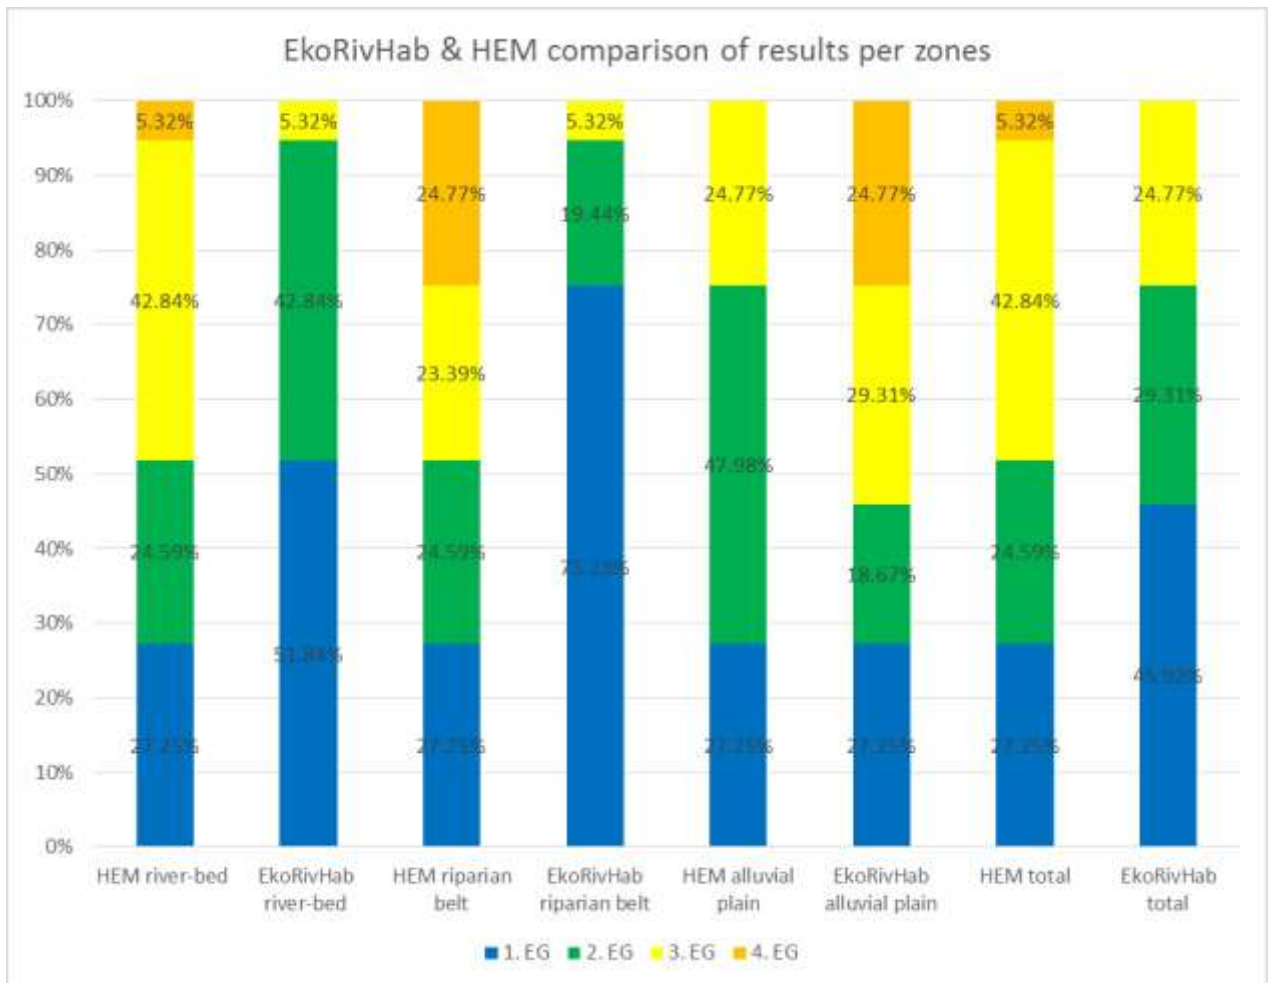
Graph 6. Comparison per zones of the two used methods

As per zones, the results vary much more than per the summary evaluation. There is especially a huge difference in terms of the riverbed and the riparian belt evaluation. It is

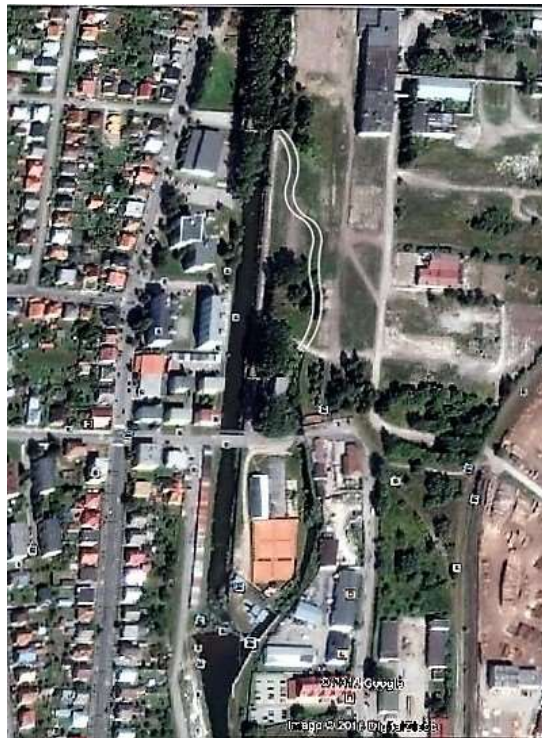
Picture 16. Migration path proposal using blind cutoff

The other big obstacle on the Revúca River is the previously mentioned two-meter step in section RE07/REV_001. There is a very positive fact that in the past the river was much more channeled and luckily there is still a blind cutoff present. As a part of this work there is a proposal design for the revitalization and migration path.

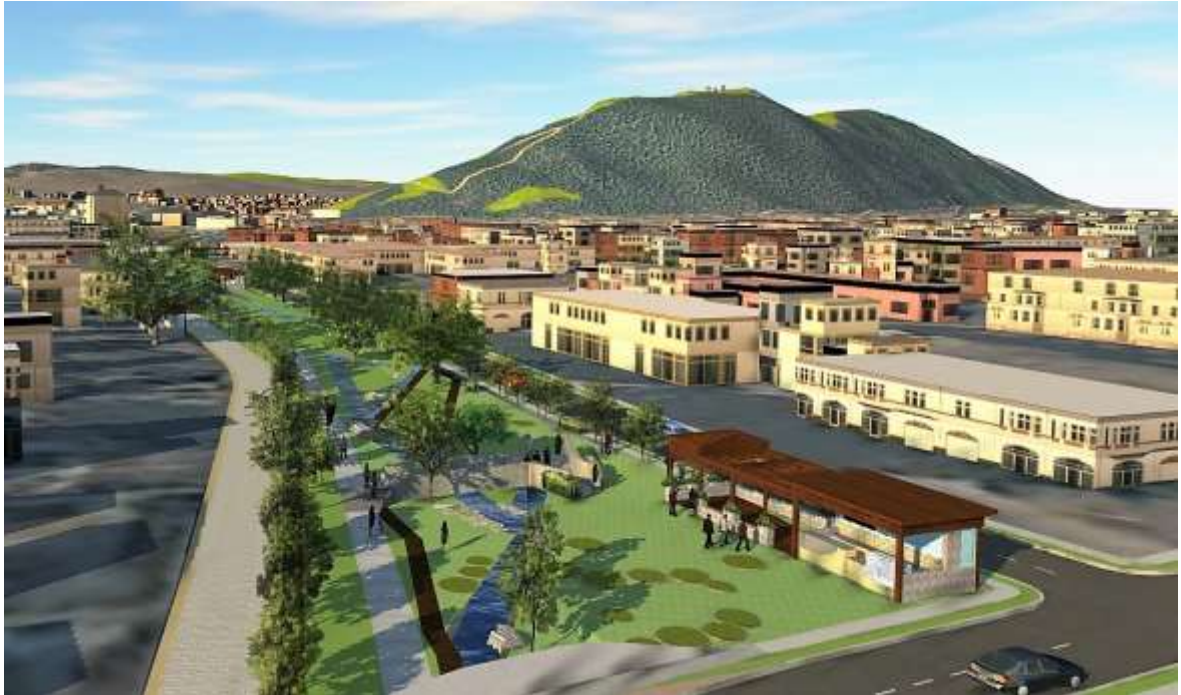
Also, as the section RE07/REV_001 river-bank modification has been dimensioned taking a Q100 discharge. However, this one hundred years discharge has never been

fulfilled as the already 70 years of presence have shown that the flood discharge has not been so high. Likewise, in a project created in 1988 for a possible reconstruction of the whole river, it is mentioned that this was over dimensioned. Therefore it could be a nice opportunity to bring this strongly modified section to a revitalized river that flows in the urbanized area closer to its natural state.

Picture 17. Revitalization proposal for RE07/REV_001 section

The design was done along with the nature close state idea. So that the river will be higher in natural quality without losing the function of technical adjustments done in the past. As Pretty et al (2003) recommends, there was put a high emphasis on the flow variability creation. There were put various representatives guaranteeing the flow variability in the revitalization design. The main ones are the whole stream direction change to more curves, differently sized stones and wooden particles inside of the stream that helps to increase the river-bottom broken relief. Also the river-bank structure is designed so it can retain more water and maintain the usual water temperature without giving it a chance to overheat as Just (2010) advises. Juncker and
