## Praha + Beroun + Plzeň

Halouny, křižovatka ulic Na Pišťák a Březova; 49°53' 23" s.š., 14°12'51" v.d., 390m n.m.

Datum: 1/31/2018  
 Počasí: 8-10 °C, polojasno

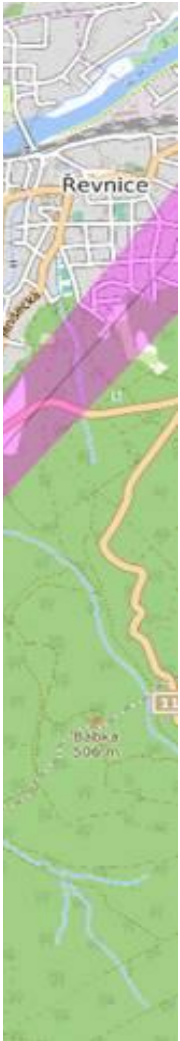
směr Radeč SFN v pořádku

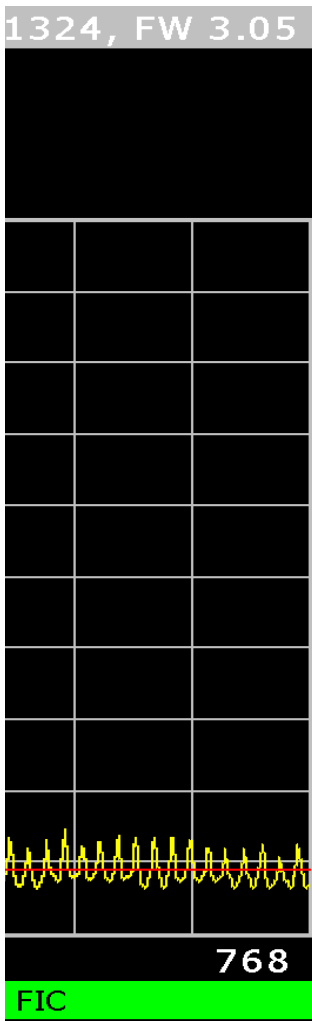
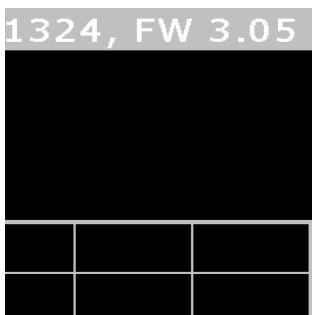
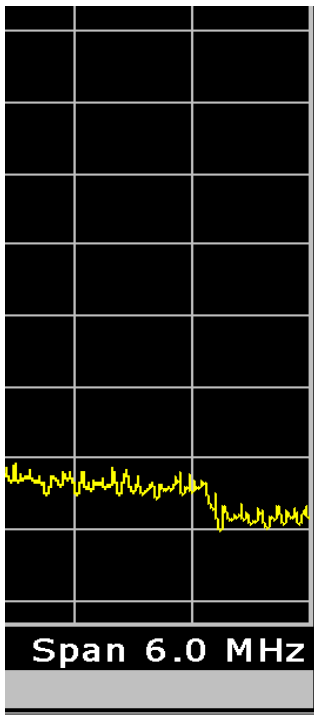
B	Time/ $\mu$ s
9.4	767.220
9.8	758.609
9.9	805.152
0.2	748.170
0.4	701.901

Limit	Unit
117.0	dB $\mu$ V
30000.0	Hz
100.0	ppm
-----	dB
