CZECH UNIVERSITY OF LIFE SCIENCES PRAGUE
FACULTY OF ENVIRONMENTAL SCIENCES
Department of Land Use and Improvement

DIPLOMA THESIS

**TOURIST TRAILS IN KRKONOŠE MOUNTAINS NATIONAL PARK –
IDENTIFICATION OF THE EXISTING AND POTENTIAL AREAS THREATENED BY
EROSION**

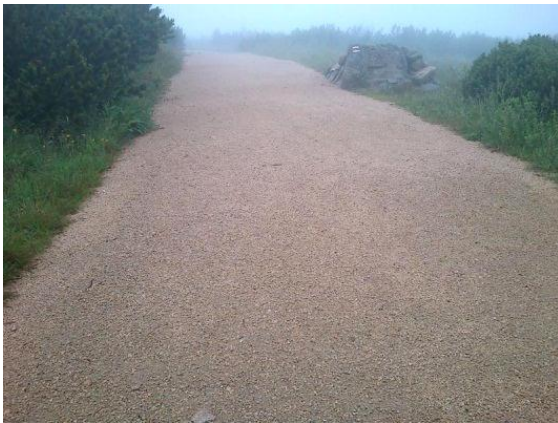
Figure 4 Trail with compacted weathered granite gravel surface (Photo:Author)

According to the type of surface, trails in Krkonoše Mountains NP can be categorized in the following way: compacted earth, stone-tiled path, stone-pitched path and wooden path (Novotný, 2007). Locally sourced compacted weathered granite gravel (CWGG) (see Figure 4) called 'perk' in Czech, which is used on Krkonoše's trails to replace the non-native alkaline gravel, belongs amongst the compacted-earth category of surfaces.

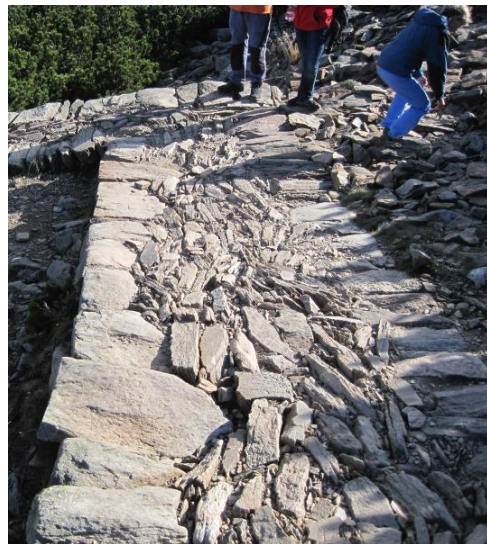
Figure 5 Trail with pitched-stone surface (Photo: Author)

In the last two decades, a traditional path-building technique of stone-pitching has been brought back to life. This technique uses stones of a minimum length of 30cm (Novotný, 2007). These stones are pitched on their longest narrow side next to each other. Smaller stones are then wedged in the gaps between the stones so that the whole structure is firmly fixed. Large boulders form the edges of such a trail (see Figure 5). This type of trail is constructed manually and requires specific skills and knowledge of the technique. Well-constructed stone-pitched trail can survive extreme weather conditions and remain functional for decades (Novotný, 2015).

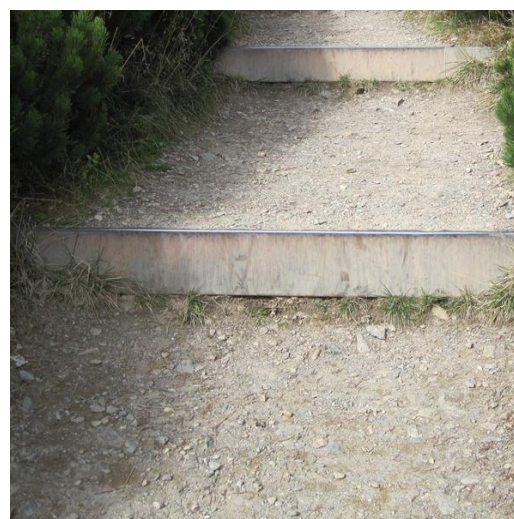
Figure 6 Trail to Snezka - eroded steps (Photo: Author)

this part of the trail was conducted in 1997-9 and it was one of the first trails where the technique of stone pitching was used in modern times. The extensive use of the trail and flaws in the construction mean that signs of trail erosion clearly visible today (loose stones, originally 15cm high steps eroded to a depth of 30cm (Figure 6), sediment in water bars).

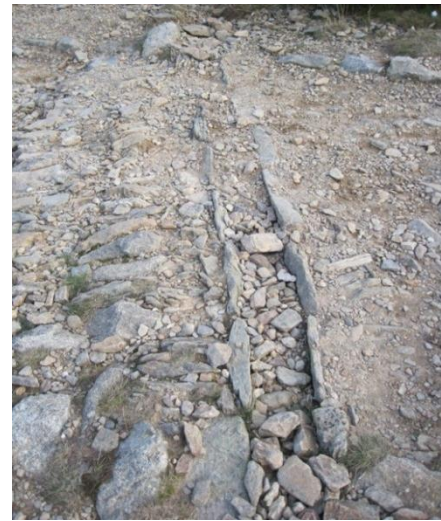
Figure 7 Sediment in water bars – Jelenka trail (Photo: Author)

thousands of years that form the shapes and positions of stones, and therefore keeping tourists on the path is highly desired. The surface of a large part of this trail is covered by pitched stone, which was mainly constructed in 2012. Erosion is manifested as sediment (gravel, small and larger stones) in water bars and parallel ditches (Figure 7).

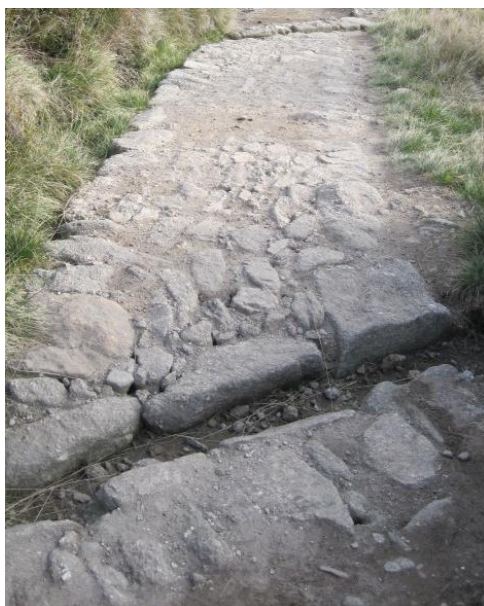
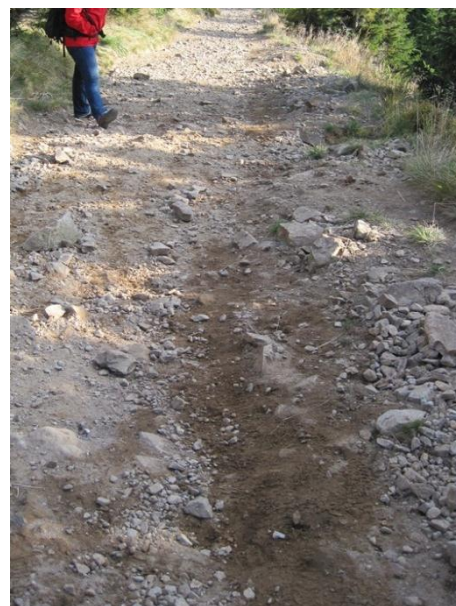
Figure 8 Reconstructed (left) and old (right) sections of trail through Obří důl (Photo: Author)

A trail that runs through the steep valley of Obří důl ('Giant Mine') and is a popular access route to Sněžka, though it is not accessible in winter due to avalanche danger. The upper parts of the trail are steep and combine stone sections (tiled and pitched) with compacted weathered granite gravel (Figure 8). The latest reconstruction in 2011 focused on some of the most eroded sections, where erosion had forced people off the trail. Today, the repaired segments show minor signs of erosion, such as sediment traces at the orifice of water bars, and the top layer of compacted weathered granite gravel has been washed away in some places to reveal underlying stones.

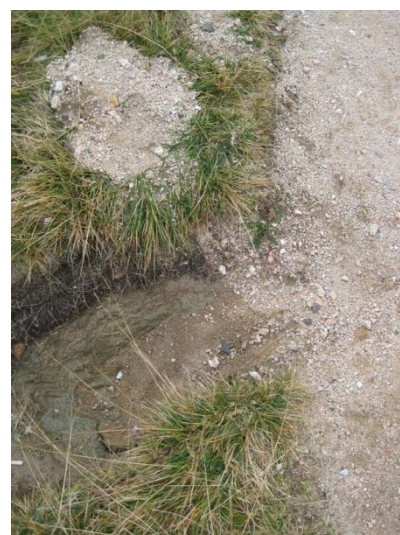
Figure 9 Recently cleaned water bar orifice - Pramen Labe trail (Photo Author)

This short stretch is a part of a longer trail starting at the crossing of tourist trails called U Čtyř pánů. As this trail leads to one of the landmarks of Krkonoše and a point of national interest – the spring of the river Labe - it belongs among the popular routes and therefore is very wide. The latest reconstruction in 2007 built a CWGG surface. Only minor visible erosion signs indicate that the erosive agent is wind as well as water - several places with exposed stones from the underlying layer of the path, some granite gravel sediment found in the water bars orifices and in the surrounding vegetation (Figure 9).

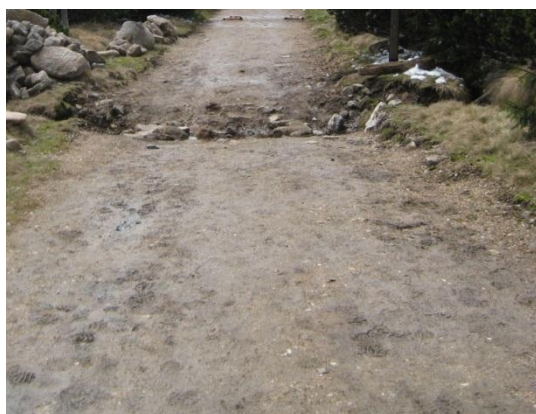
Figure 10 Trail to Tvarožník - prior to the reconstruction (Photo: KRNAP)

This trail partially follows the border with Poland (red trail) and turns to the South towards Vosecká bouda at a point called Svinské kameny (yellow trail). This trail is one of many where alkaline gravel was used. During the latest reconstruction, which was completed in autumn 2014, the alkaline

material was removed and replaced with locally sourced CWGG. The steepest parts of the trail were surfaced using the pitched stone technique. As the reconstruction was completed only several weeks before the data collection, no signs of erosion could be detected on this trail. Based on the pre-reconstruction photos (Figure 10) and a discussion with the Head of the Department of Investments, the trail has been included among those suffering predominantly from water erosion.

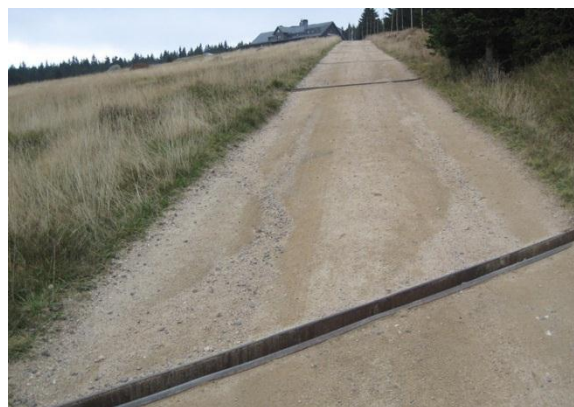
Figure 11 Vosecká trail - ruts with eroded CWGG (Photo: Author)

The studied trail section is a 1-km-long CWGG part of this trail. It begins by the Vosecká chalet and finishes by an asphalt road at a point called Pod Voseckou boudou. This route is the only one that is not purely pedestrian as it serves as an access route for cars delivering supplies to Vosecká bouda, and since 2010 also for cyclists. Clear signs of erosion are visible on this trail – ruts created by cars, holes, and in some places removed fine top-layer material as well as gravel (see Figure 11). Metal water bars and the parallel ditch show sediment run-off from the trail.

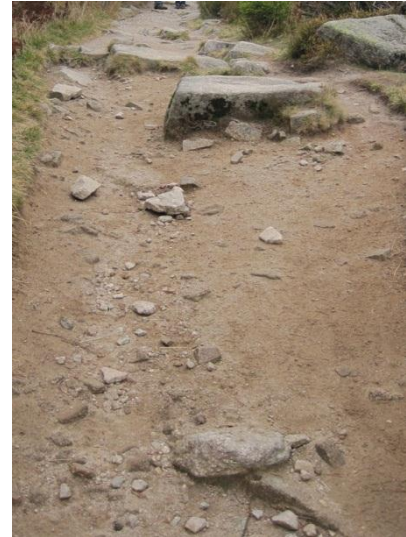
Figure 12 Eroded trail at Pančava waterfall (Photo: Author)

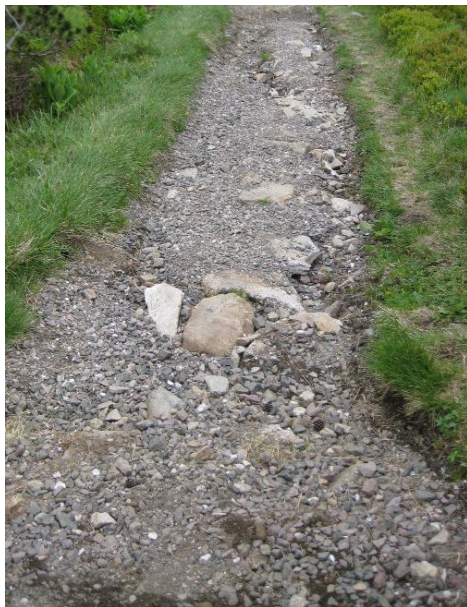
Figure 13 Eroded trail to Jestřábí bouda with alkaline material (Photo: KRNAP)

Yellow trail running uphill from Horní Mísečky represents an alternative route to the red trail, which follows the asphalt road. It has been acquired by KRNAP only in 2013 from the municipality of Vítkovice. The trail surface was covered partially by alkaline gravel (see Figure 13) and in some sections by stone; the majority of the trail is, however, compacted earth. The trail had not been maintained appropriately and thus the man-made sections are in a very poor state. Rill erosion, loose boulders and eroded fine particles can be observed along the course of the trail. The parallel ditch, where it exists, is

overgrown and has lost its function. A short stretch of the trail (approx. 200m in the upper, steep part of the trail) was repaired in 2014. The basic material was removed and replaced by a stone-pitched surface with stone water bars and a parallel ditch.

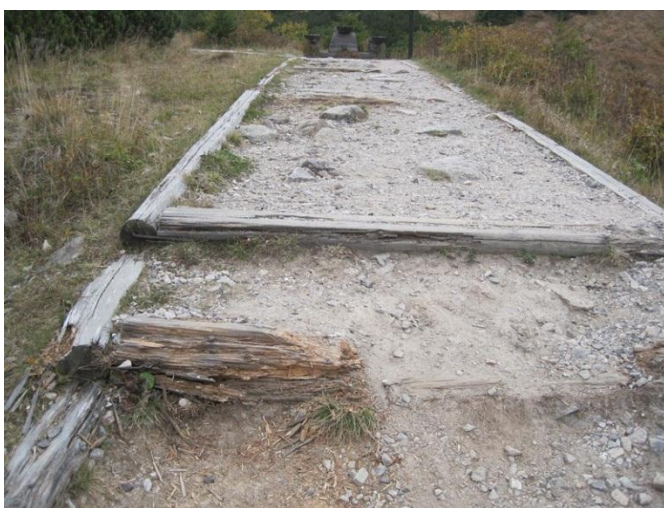
Figure 14 Erosion on trail to Labský důl (Photo: Author)

The section of the trail that this study focused on lies directly under the chalet Labská bouda. It is the steepest part that passes by a waterfall (Labský vodopád) and then continues in zig-zag towards the bottom of the valley (Labský důl). The very top part of the trail is constructed as CWGG in wooden frames, which form steps. This part was built approximately 15 years ago and weathering of the materials as well as erosion is clearly visible (Figure 14) – removed top layer of the trail, underlying stones revealed and loose stones. Some eroded spots have led tourist to finding alternative routes and multiple treads and trail widening can therefore be found here too.

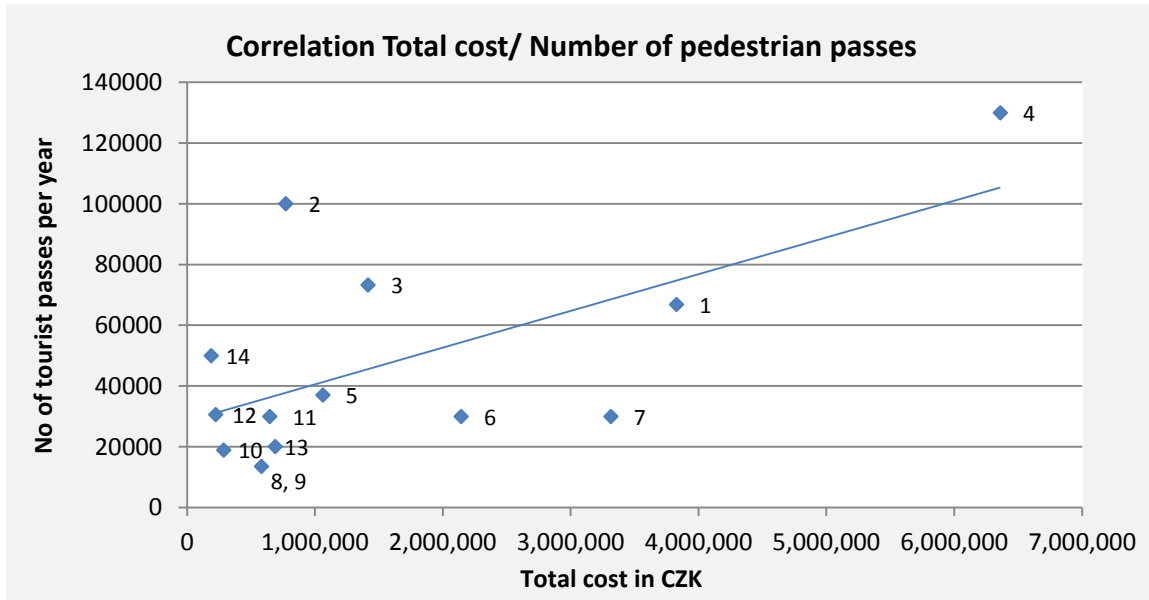
Figure 19 Trails (trail codes) displayed in a positive correlation between the Total cost and the number of pedestrian passes per year

The additional analysis of the total cost did not indicate any correlation with the trail surface; however, correlation between the total cost and the number of tourist passes was revealed, showing a correlation factor of 0.634. This moderate positive relationship as displayed in a graph (see Figure 19) indicates that more tourists means that higher cost had to be invested into reconstruction and maintenance (or vice versa), regardless of the trail surface.
