Universität für Bodenkultur Wien

Design of a Sustainable Operation and Maintenance Concept of the Water Supply System of Paroisse de Rwaza (Rwanda)

Master Thesis

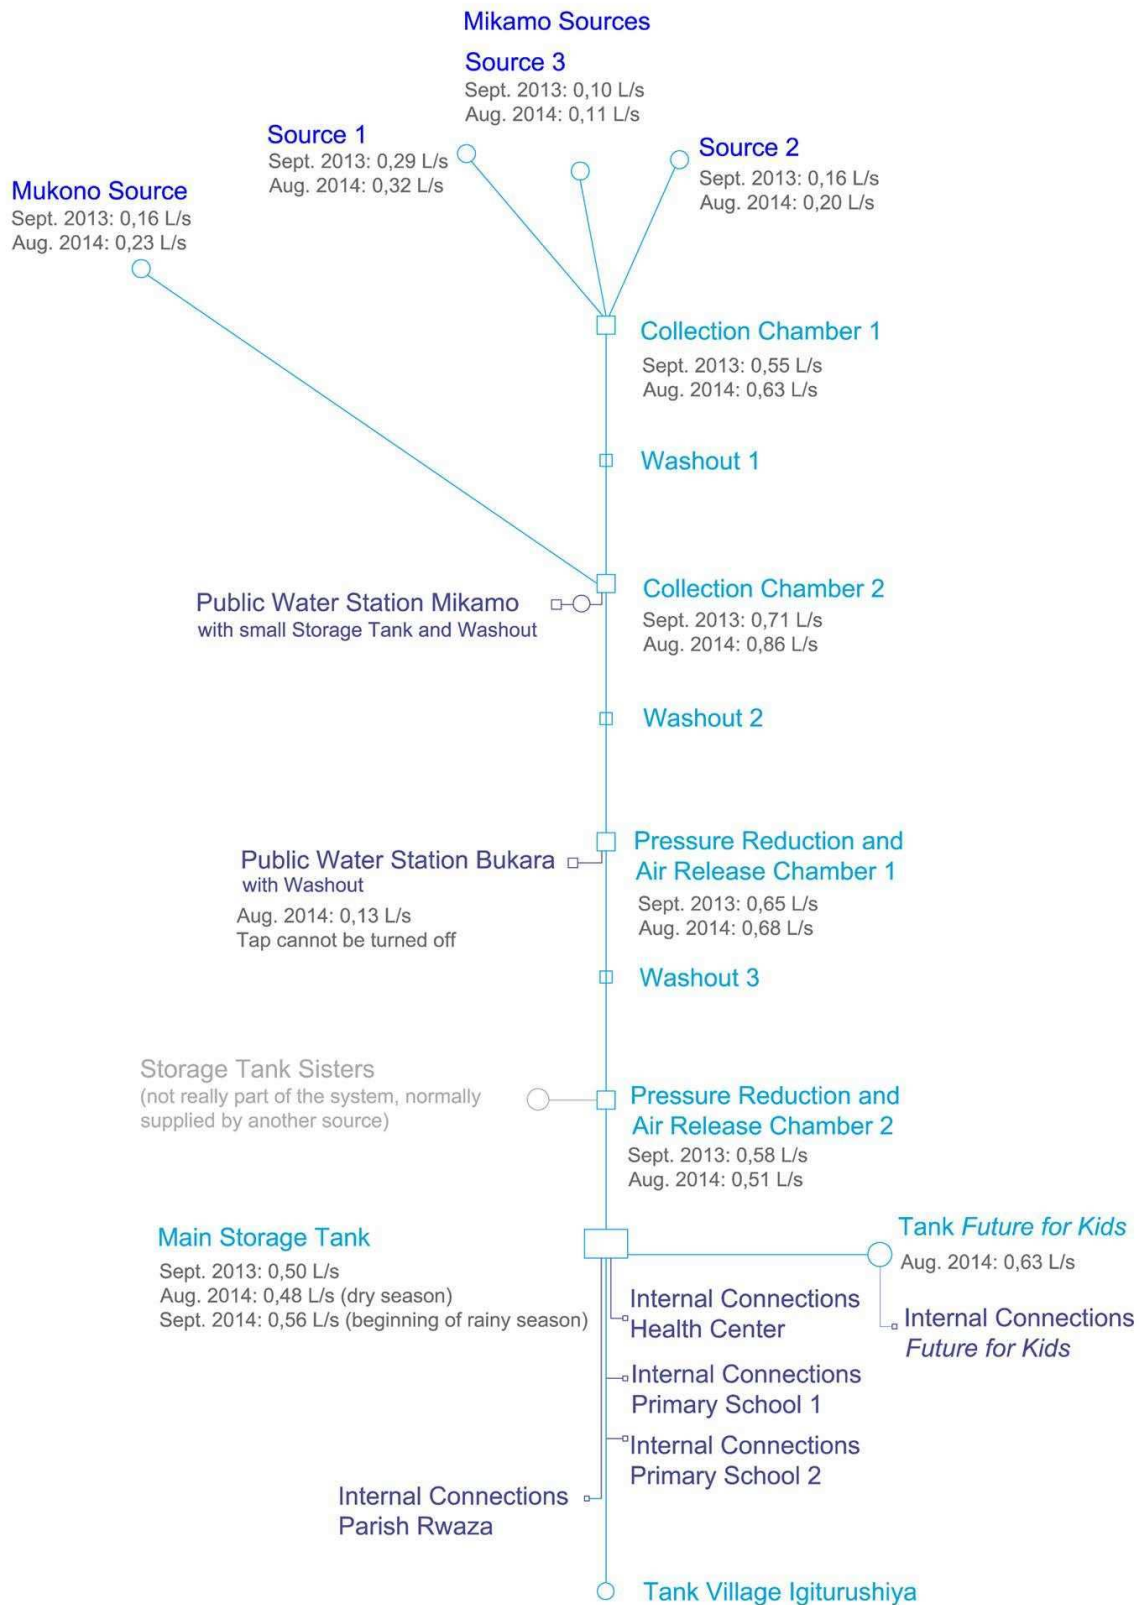
Figure 5: Flow chart of the water supply system of Rwaza

The system boundaries were defined in a way that the object of inquiry includes the whole water supply system from the springs to the household connection level. Only the *Future for Kids* complex also includes the household level. Since its extension to the orphanage in December 2013, the water supply system of the parish Rwaza supplies approximately 800 people and consists at present of the following parts (Figure 5):

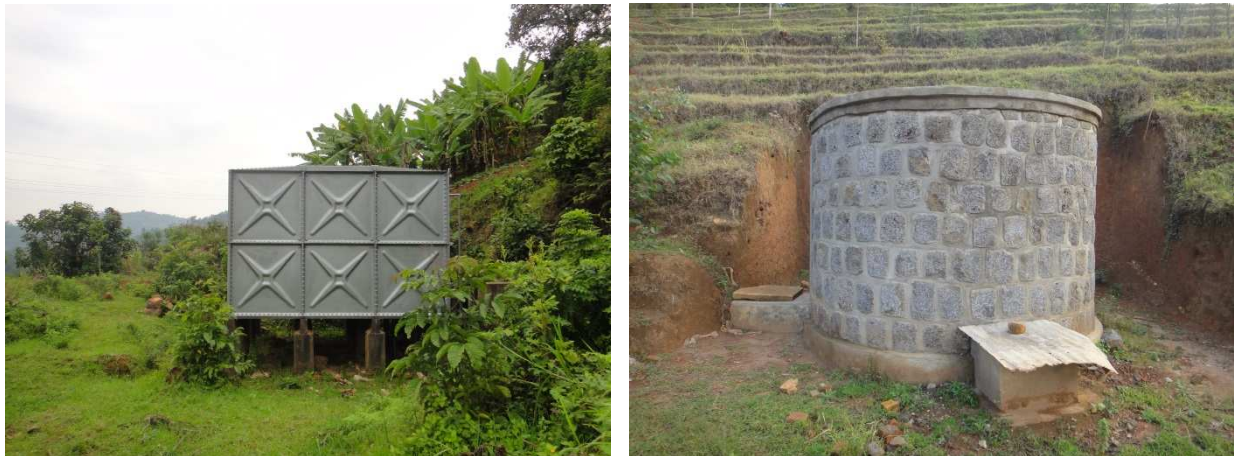
Figure 6: Main storage tank (left) and tank *Future for Kids* (right) (own pictures, 2014)

The buildings of the orphanage *Future for Kids* were connected to the old system (which is described in chapter 3.6) by a pipe that is attached on the side of the main storage tank (Figure 6, left image) approximately 30 centimetres above the bottom. This pipe conveys the water to the newly built brick tank of the centre (Figure 6, right image). The circular shaped tank has a capacity of 15,000 litres and is equipped with a float valve and a washout, but is missing a ventilation pipe. It is the starting point of the orphanage's internal connections, where the buildings of the centre are supplied from [Appendix 11.1 Water and wastewater system *Future for Kids*]. In the orphanage complex there are two outdoor taps (one at the cow stable and one in front of the girls' dormitory), 17 showers (seven for girls, seven for boys and three for the staff and guests), three water toilets (two night toilets for the children, one for girls and one for boys, and one for the staff and guests), three kitchen taps and one water tap in the guest bathroom, that are supplied via the water supply system.

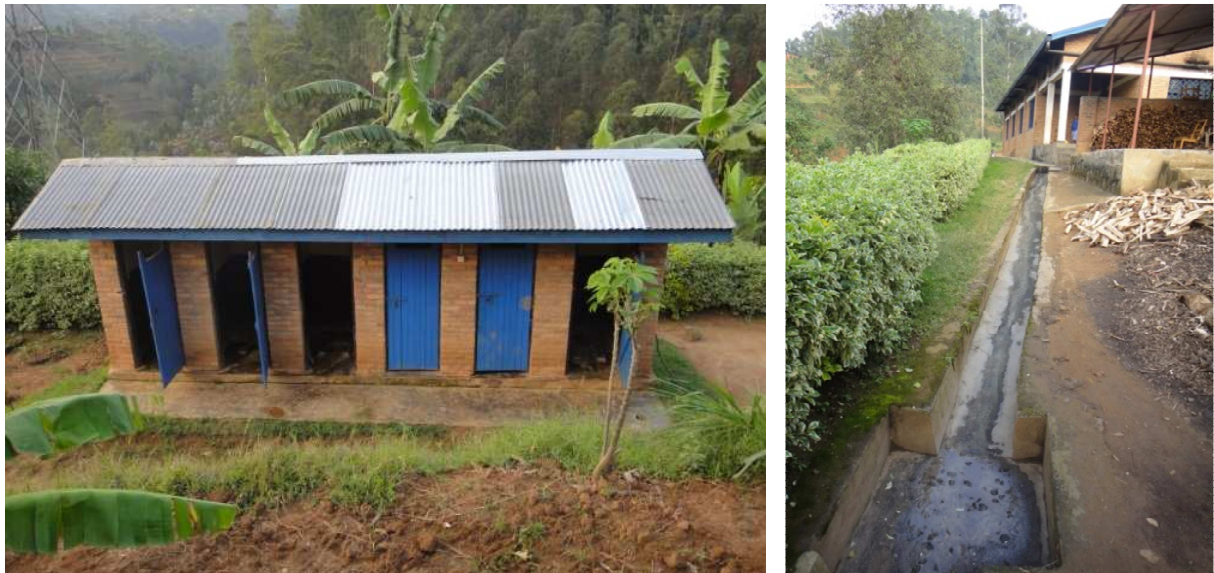
Figure 7: Pit Latrines (left) and storm water gully at *Future for Kids* (right) (own pictures, 2014)

In the course of the system description also the wastewater management at the orphanage was investigated and an overview plan of the wastewater facilities at the complex was drawn [Appendix 11.1 Water and wastewater system *Future for Kids*]. The black-water from the two flushed night toilets as well as from the guest toilet, is in all cases collected in brick made septic tanks that are situated in the ground next to the two dormitories and the guest house respectively. Each of these septic tanks consists of three separated chambers that are connected due to a crack between the partition walls and the ceiling of the tank. Solid material is therefore collected at the bottom of the first chamber, where it is decomposed, while liquids can flow into the second compartment as soon as the first one is full. When the second chamber is full, the third one gets filled and as soon as the third section reaches its capacity the liquid is conveyed into an attached soak pit via a pipe from where the fluid seeps into the ground. Apart from the flushed water toilets there are two older dry pit latrine facilities, with six pit latrines each (Figure 7, left image). Underneath the latrines there is a container, where the faeces are collected. When the container is full, the buried cover is dug out and the container is opened and emptied. Therefore a new hole is dug in a not yet specified place where the faeces are put inside. The grey water from the showers of the dormitories and of the guest house is directly conveyed into the soak pits that are next to the septic tanks. Grey water from the kitchen taps flows into a soak pit that is situated next to the kitchen, from where it seeps into the ground. Storm water runoff is drained via open rain water trenches next to the buildings that guide the water into the trench next to the guesthouse from where the water eventually infiltrates into the grass (Figure 7, right image).
