**Diploma Thesis**

**Feasibility study of river restoration measures and  
the patency of migration barriers on the Knovízský  
stream**

**Author:** Bc. Kateřina Dvořáková

**Prague 2014**

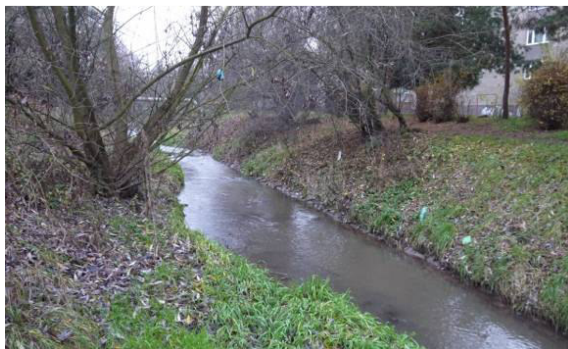
**Figure 15:** Banks have a steep slope character

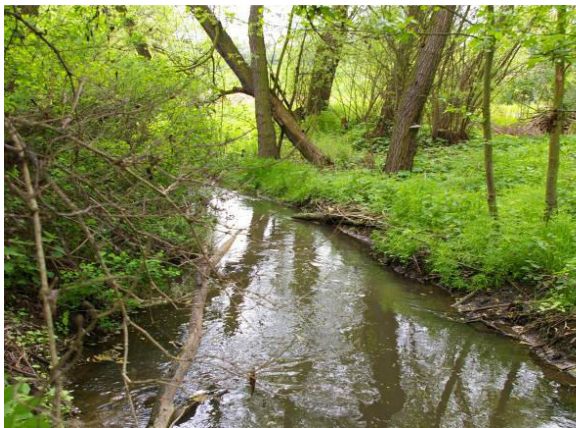
**Figure 20: The stream on inflow into village Zeměchy**

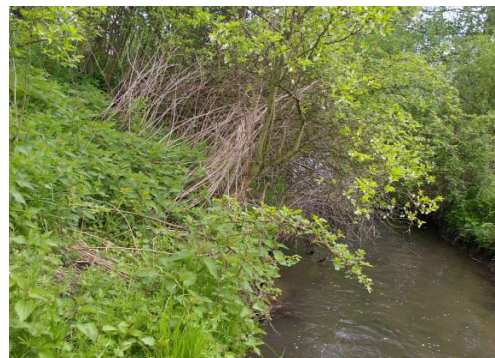
The stream is overgrown with dense riparian vegetation and the river bed shows the natural character. Up the stream, the stream line is curved and the bank line has also a more natural shape.

**Figure 29: Dense riparian vegetation**

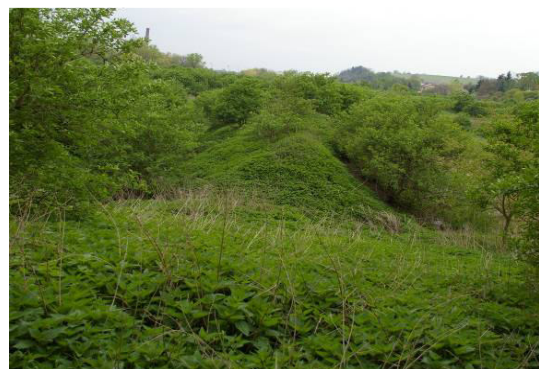
**Figure 31: Retention tanks used in past – nowadays overgrown by vegetation**

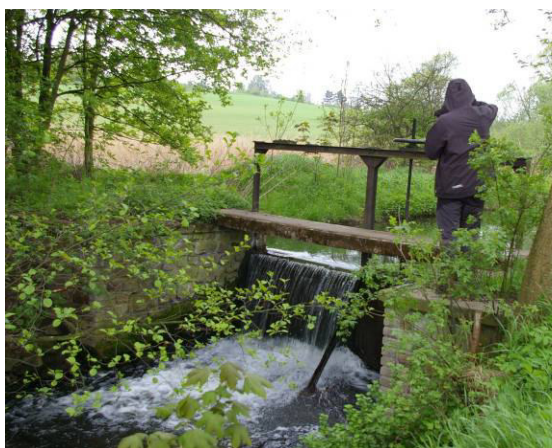
**Figure 34: Water divider of pond Otrok**

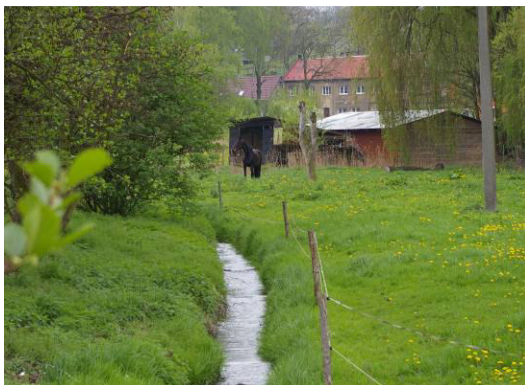
others which names are not known. In the village, the stream is straightened and it does not have the appropriate flow capacity.

**Figure 44: The stream bed with small capacity**

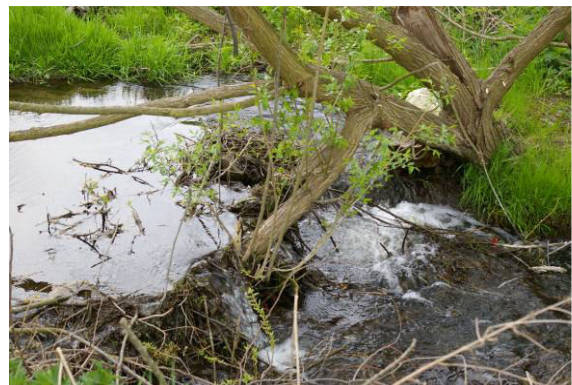
The village Třebichovice is the last village of our area of interest. At the beginning of the village, the vegetation quite often fell into the stream bed and created a migration barrier which can also cause flooding. The stream bed is very well maintained, the riparian vegetation was eliminated before we did our observation. The stream has several tributaries in the village - Svinařovský stream, and many

**Figure 45: Fell vegetation – migration barriers on stream**
